MEMORANDUM

Subject: Tunnel Creek Properties LLC Land Capability Challenge; 1200 Tunnel Creek Road, Washoe County, NV; Assessor's Parcel No: 130-311-17, TRPA File No: LCAP2015-0470

Proposed Action: Hearings Officer review and approval of the proposed Land Capability Challenge.

TRPA Contractor Soil Profile Descriptions
(from Terra Science, Inc.)

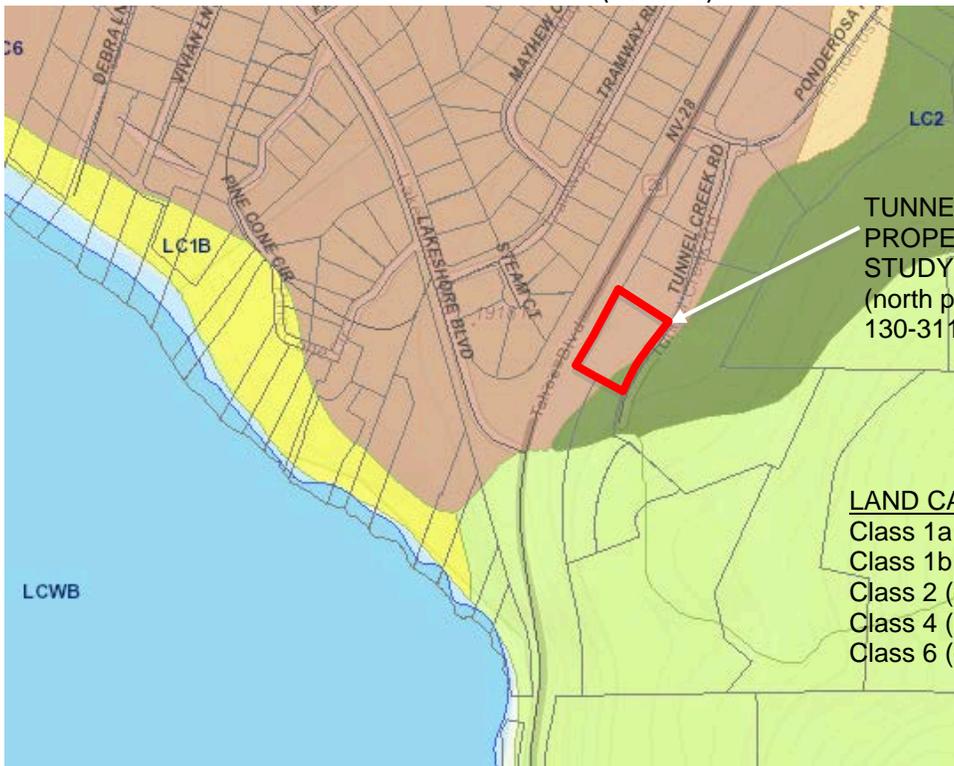
TRPA LAND CAPABILITY MAP (no scale)

TUNNEL CREEK
PROPERTIES LLC
STUDY AREA
(north part of APN
130-311-017)

LAND CAPABILITY
Class 1a (light green)
Class 1b (yellow)
Class 2 (olive green)
Class 4 (light tan)
Class 6 (dark tan)

Background: The subject parcel is shown as having both Class 1a and Class 6 on TRPA Land Capability Overlay Maps (aka Bailey Land Capability maps, Attachment A). The Class 6 land is designated for the land in the center, north and west, while the moderately sloped southeast corner is designated Class 2. The Soil Conservation Service Soil Survey of Tahoe Basin Area, California-Nevada (Rogers, 1974) identifies the west and center portions as Inville very stony sandy loam, 2 to 9% (IsC). The southeast corner of the study area is mapped as Cagwin-Rock outcrop complex, 15 to 30% slopes (CaE). The CaE soil can have 5 to 15% rock surface cover and bedrock 20 to 40 inches from the surface. The soil component is typically loamy coarse sand atop partially weathered granodiorite (grus). The grus layer may not show significant evidence of soil formation, but it can contain fine to medium-sized roots. The vicinity of this parcel has a geomorphic mapping of E-2 for Outwash, till, and lake deposits (low hazard land) for the center, north and west parts; and C-2 for Strongly dissected lands (high hazard lands) for the southeast corner. There are no Stream Environment Zones (SEZs) present, nor in close proximity.

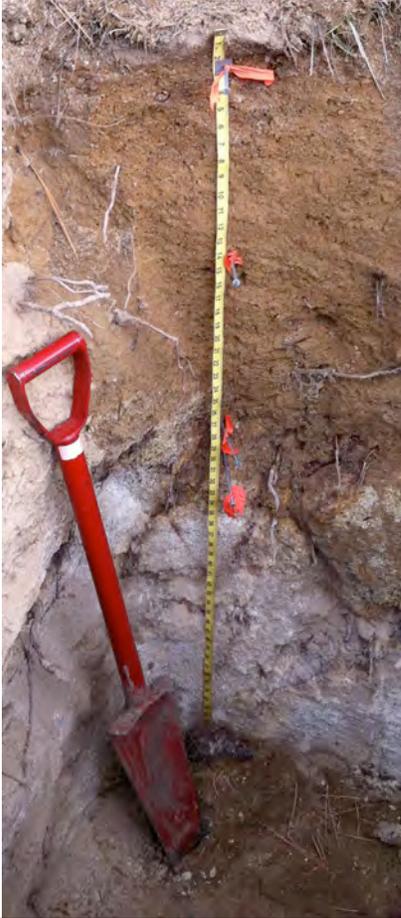
Photo 1 – View of soil profile. Test pit depth 60+ inches. Weathered bedrock occurs at 46-inch depth.

Layer	Depth (In.)	Color (moist)	Soil Properties / Features
O	0 to 0.5	Black (10YR 2/1)	DUFF, twigs, pine needles, grass thatch, abrupt boundary.
A	0.5 to 2.5	Very dark brown (10YR 2/2)	LOAMY COARSE SAND, weak granular structure, <5% gravel, no redox features, many very fine, fine, medium roots, many fine interstitial pores, abrupt boundary. Appears that 6 to 8 in. topsoil previously removed.
Bw	2.5 to 28	Dark yellowish brown (10YR 3/4)	LOAMY COARSE SAND, weak subangular blocky structure, 10 to 15% gravel, no redox features, few fine, medium and coarse roots, many medium interstitial pores, clear boundary.
C	28 to 46	Dark yellowish brown (10YR 4/4)	LOAMY COARSE SAND, massive structure, 20 to 25% gravel, no redox features, few fine and coarse roots, many medium interstitial pores, abrupt boundary. Pea-sized fragments mostly break down to coarse sand when wetted – soil fines within matrix. This layer contain floater rocks (partially weathered).

Cr / R	46 to 60+	White and Black (speckled grains)	BEDROCK (partially weathered granodiorite), coarse roots penetrate fractures in bedrock 24 to 36 inches apart (horizontally). Backhoe able to dig through bedrock, but rock is too hard to dig with shovel.

Soil is significantly different than mapped soils (Cagwin-Rock outcrop complex, 15-30% slopes-CaE and Inville stony coarse sandy loam, 2 to 9% slopes—IsC). See report discussion. Soil is similar, but less developed than Cassenai series (2006 NRCS soil survey, 15 to 30% slopes); however, this is an unnamed soil (XXX) in the 1974 SCS soil survey. For moderate hazard lands, slopes 16 to 30% qualify as Class 4 (20% allowable coverage).

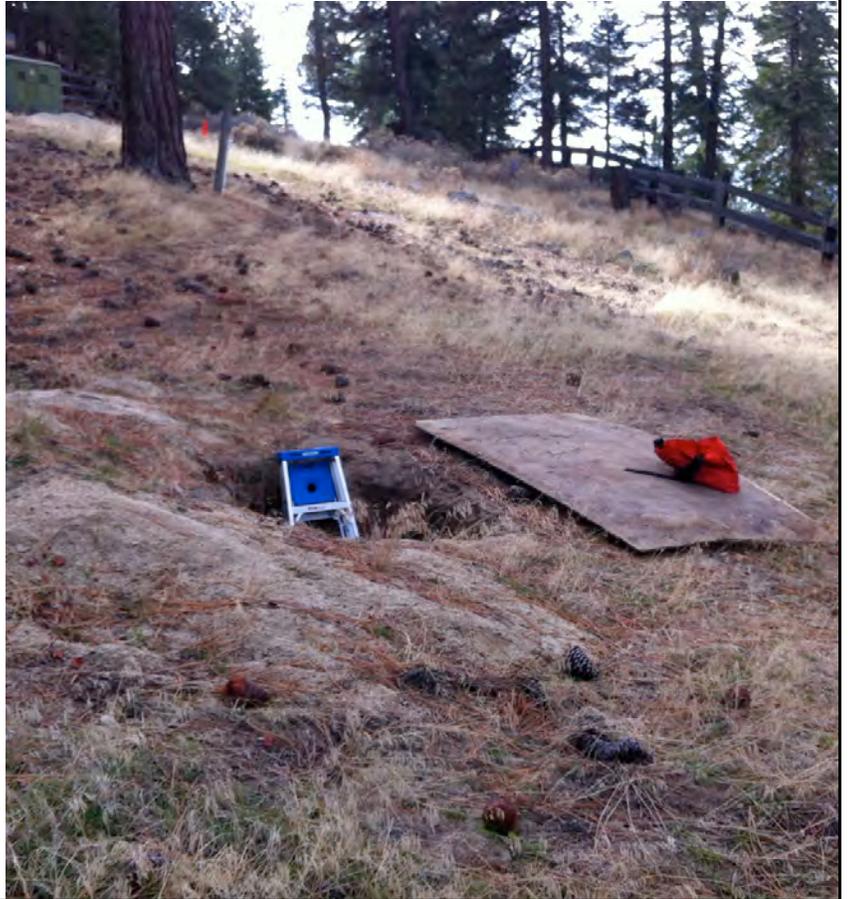
Photo 2 – View to south toward Test Pit 1, located on 17% slope, in northeast part of study area. Slope dips (falls) to north by northwest.

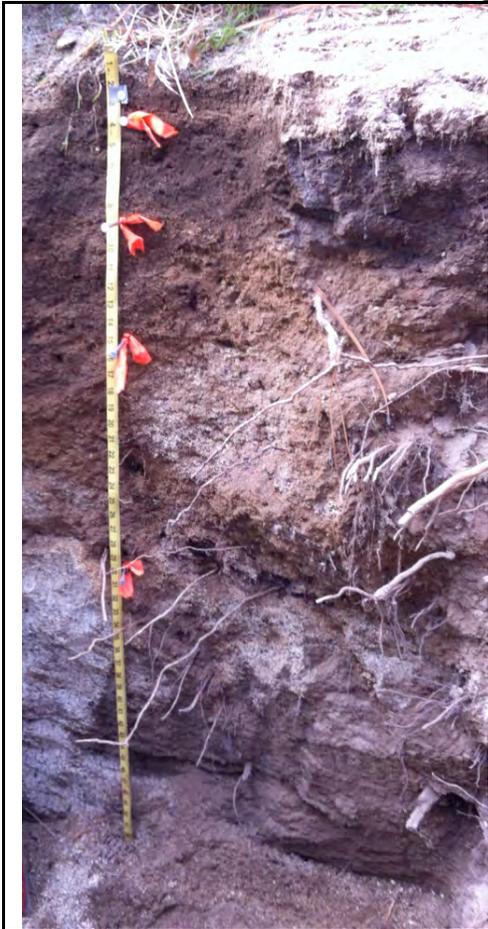
Photo 3 – View of soil profile. Test pit depth 55+ inches. Weathered bedrock occurs at 52-inch depth.

Layer	Depth (In.)	Color (moist)	Soil Properties / Features
AC	0 to 4	Very dark grayish brown (10YR 3/2)	FILL (old), weak granular structure, 10% gravel, no redox features, many fine and very fine roots, many fine interstitial pores, abrupt boundary. Grass/forb coverage is >90%.
Ab1	4 to 8.5	Very dark brown (10YR 2/2)	LOAMY COARSE SAND, weak granular structure, <5% gravel, no redox features, many fine and very fine roots, few medium and coarse roots, many fine interstitial pores, abrupt boundary.
Ab2	8.5 to 15	Very dark grayish brown (10YR 3/2)	LOAMY COARSE SAND, weak subangular blocky structure, 15% gravel, no redox features, common fine and medium roots, common coarse roots, many medium interstitial pores, abrupt boundary.
C	15 to 30.5	Dark yellowish brown (10YR 3/ 4)	LOAMY COARSE SAND, massive structure, 20% gravel, no redox features, common fine, medium and coarse roots, many medium interstitial pores, abrupt boundary. This layer includes floater rocks (grus).

C / Cr	30.5 to 55+	Light olive brown (2.5Y 5/3)	LOAMY COARSE SAND, massive structure, 40% cobbles and stones, no redox features, common fine and medium roots, few coarse roots, many medium interstitial pores. This layer has bedrock separated by soil with many roots. Bedrock is mostly less than 24 in. wide, thus considered a soil layer.

Soil is significantly different than mapped soils (Cagwin-Rock outcrop complex, 15-30% slopes-CaE and Inville stony coarse sandy loam, 2 to 9% slopes—IsC). See report discussion. Soil is similar, but less developed than Cassenai series (2006 NRCS soil survey, 15 to 30% slopes); however, this is an unnamed soil (XXX) in the 1974 SCS soil survey. For moderate hazard lands, slopes 16 to 30% qualify as Class 4 (20% allowable coverage).

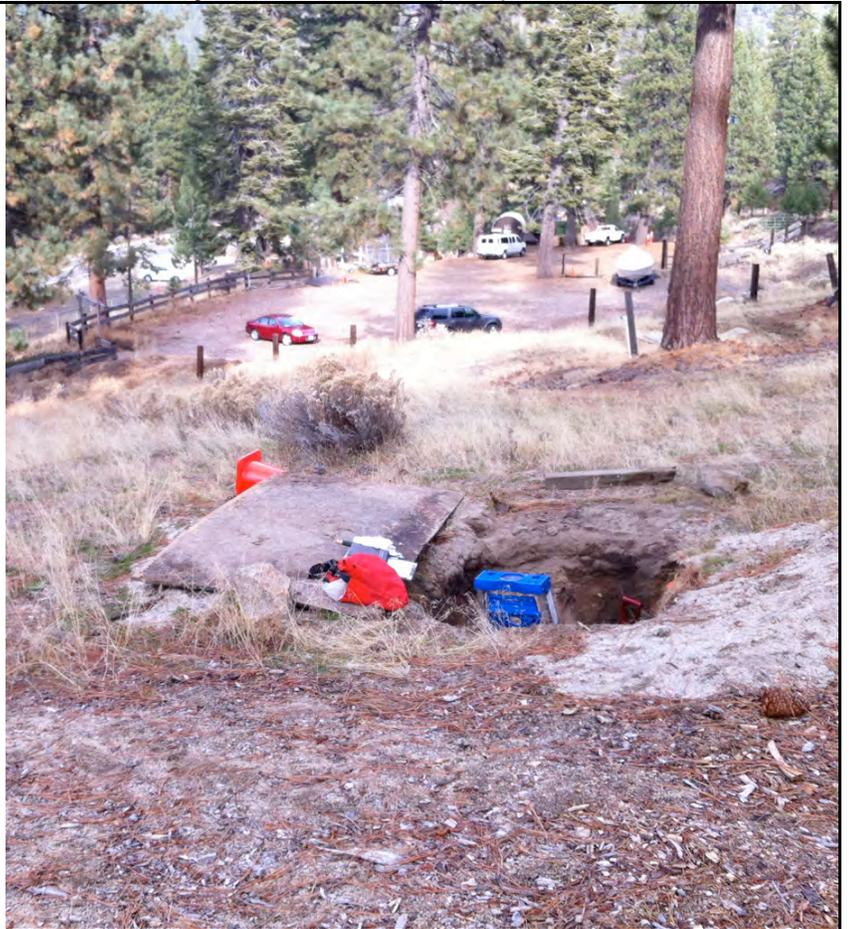
Photo 4 – View to north toward Test Pit 2, located on 13% slope, in southeast part of study area. Slope dips (falls) to north.

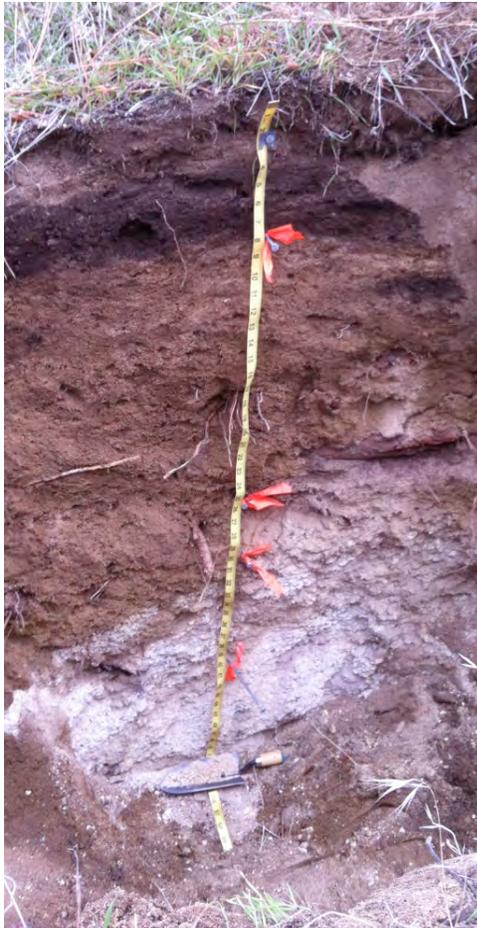
Photo 5 – View of soil profile. Test pit depth 53+ inches. Weathered bedrock occurs at 40.5-inch depth.

Layer	Depth (In.)	Color (moist)	Soil Properties / Features
AC	0 to 4	Very dark grayish brown (10YR 3/2)	FILL (old), weak granular structure, <5% gravel, no redox features, many fine and very fine roots, many fine interstitial pores, abrupt boundary. Grass/forb coverage is 100%.
Ab	4 to 8	Very dark brown (10YR 2/2)	LOAMY COARSE SAND, weak granular structure, <5% gravel, no redox features, many fine and very fine roots, few medium roots, many fine interstitial pores, abrupt boundary.
Bw	8 to 30	Dark grayish brown (10YR 3/4)	LOAMY COARSE SAND, weak subangular blocky, 10-20% gravel, no redox features, common fine and medium roots, few coarse roots, many medium interstitial pores, abrupt boundary.
C	30 to 40.5	Yellowish brown (2.5Y 5/3)	LOAMY COARSE SAND, massive structure, 30% gravel, no redox features, common medium and coarse roots, many medium interstitial pores, abrupt boundary. Pea-sized fragments mostly break down to coarse sand when wetted – soil fines within matrix.

Cr / R	40.5 to 53+	White and Black (speckled grains)	BEDROCK (partially weathered granodiorite), few medium roots penetrate fractures in greater than 30 inches apart (horizontally). Rock material is too hard to dig with shovel.

Soil resembles the mapped soils (Cagwin-Rock outcrop complex, 15-30% slopes-CaE), but not Inville stony coarse sandy loam, 2 to 9% slopes—IsC). See report discussion. Excluding fill material, soil depth is less than 40 inches thick, which corresponds to the Cagwin series (where the parent material granodiorite). Cagwin soils (CaE) on 15 to 30% slopes are designated as Class 2 (1% allowable coverage).

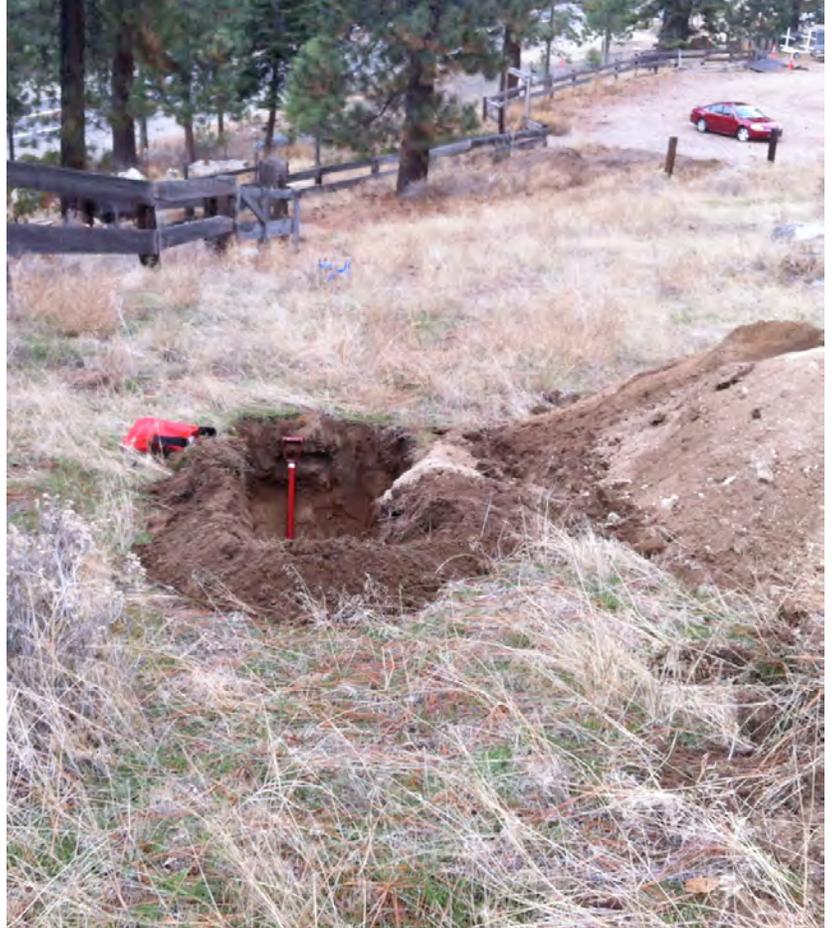
Photo 6 – View to northwest toward Test Pit 3, located on 24% slope, in west-center part of study area. Slope dips (falls) to north by northwest.

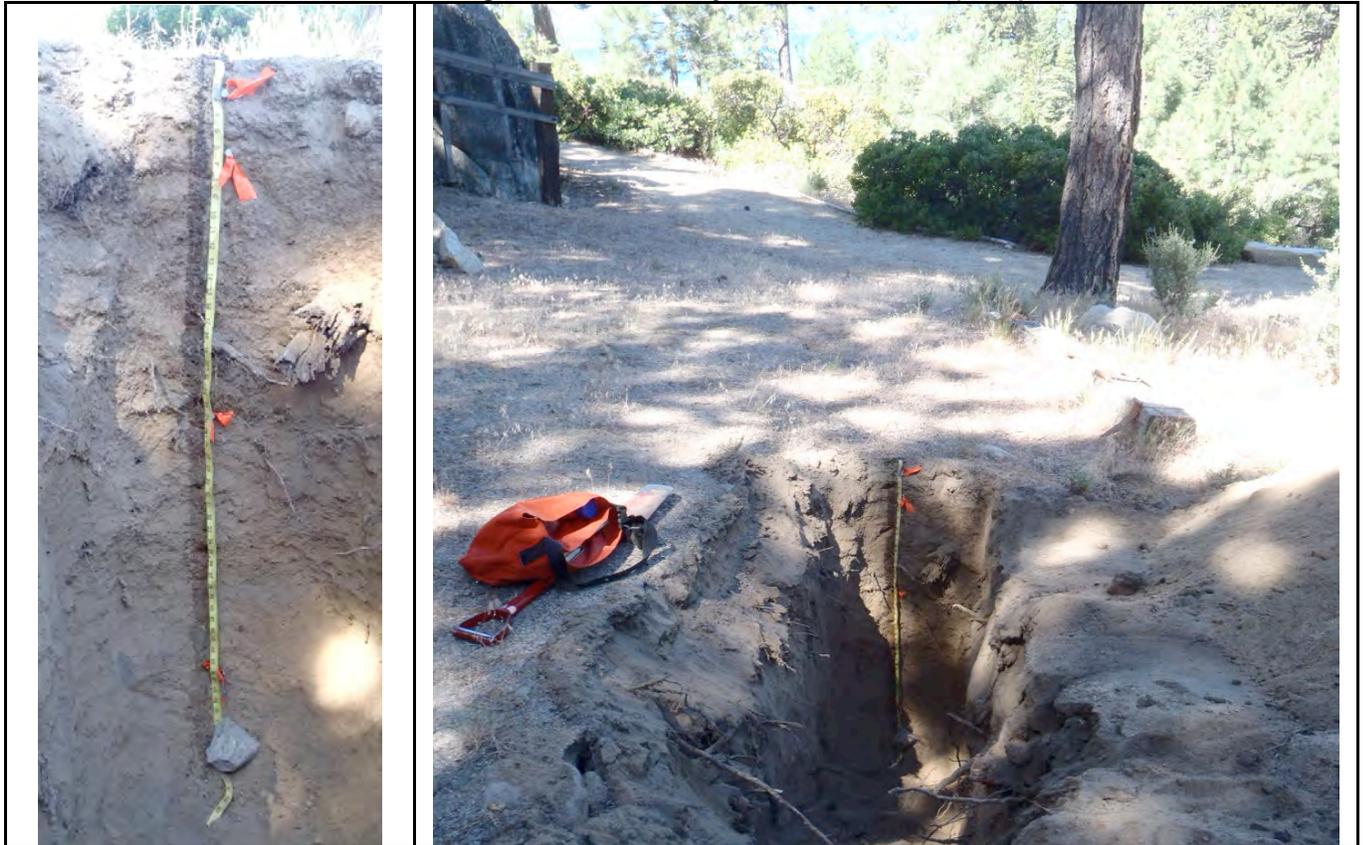
Photo 7 – View of soil profile. Test pit depth 54+ inches. Hard bedrock occurs below 54-inch depth.

Photo 8 – View to west toward Test Pit 4, located on 22% slope, in south part of study area. Slope dips (falls) to north by northwest.

Layer	Depth (In.)	Color (moist)	Soil Properties / Features
A1	0 to 2	Very dark brown (10YR 2/2)	LOAMY COARSE SAND, moderate granular structure, <5% gravel, no redox features, many fine and very fine roots, many fine interstitial pores, abrupt boundary. Grass/forb coverage is 40%, while shrub cover is additional 20%, remainder is duff.
A2	2 to 6	Dark brown (10YR 3/3)	LOAMY COARSE SAND, moderate granular structure, <5% gravel, no redox features, many fine and very fine roots, few medium roots, many fine interstitial pores, abrupt boundary.
Bw	6 to 23.5	Dark yellowish brown (10YR 3/4)	LOAMY COARSE SAND, weak subangular blocky, <5% gravel, no redox features, common fine, medium and coarse roots, many fine interstitial pores, clear boundary.
C	23.5 to 46	Brown (10YR 4/3)	LOAMY COARSE SAND, massive structure, <5% gravel, no redox features, few fine and coarse roots, common medium roots, fine interstitial pores, clear boundary.

C2	46 to 54+	Dark yellowish brown (10YR 4/4)	LOAMY COARSE SAND (Grus), massive structure, <5% gravel, no redox features, few fine and medium roots, medium interstitial pores. Pea-sized fragments mostly break down to loamy coarse sand when wetted – soil fines within matrix.

Soil is significantly different than mapped soils (Cagwin-Rock outcrop complex, 15-30% slopes-CaE and Inville stony coarse sandy loam, 2 to 9% slopes—IsC). See report discussion. Soil is similar, but less developed than Cassenai series (2006 NRCS soil survey, 15 to 30% slopes); however, this is an unnamed soil (XXX) in the 1974 SCS soil survey. For moderate hazard lands, slopes 16 to 30% qualify as Class 4 (20% allowable coverage).

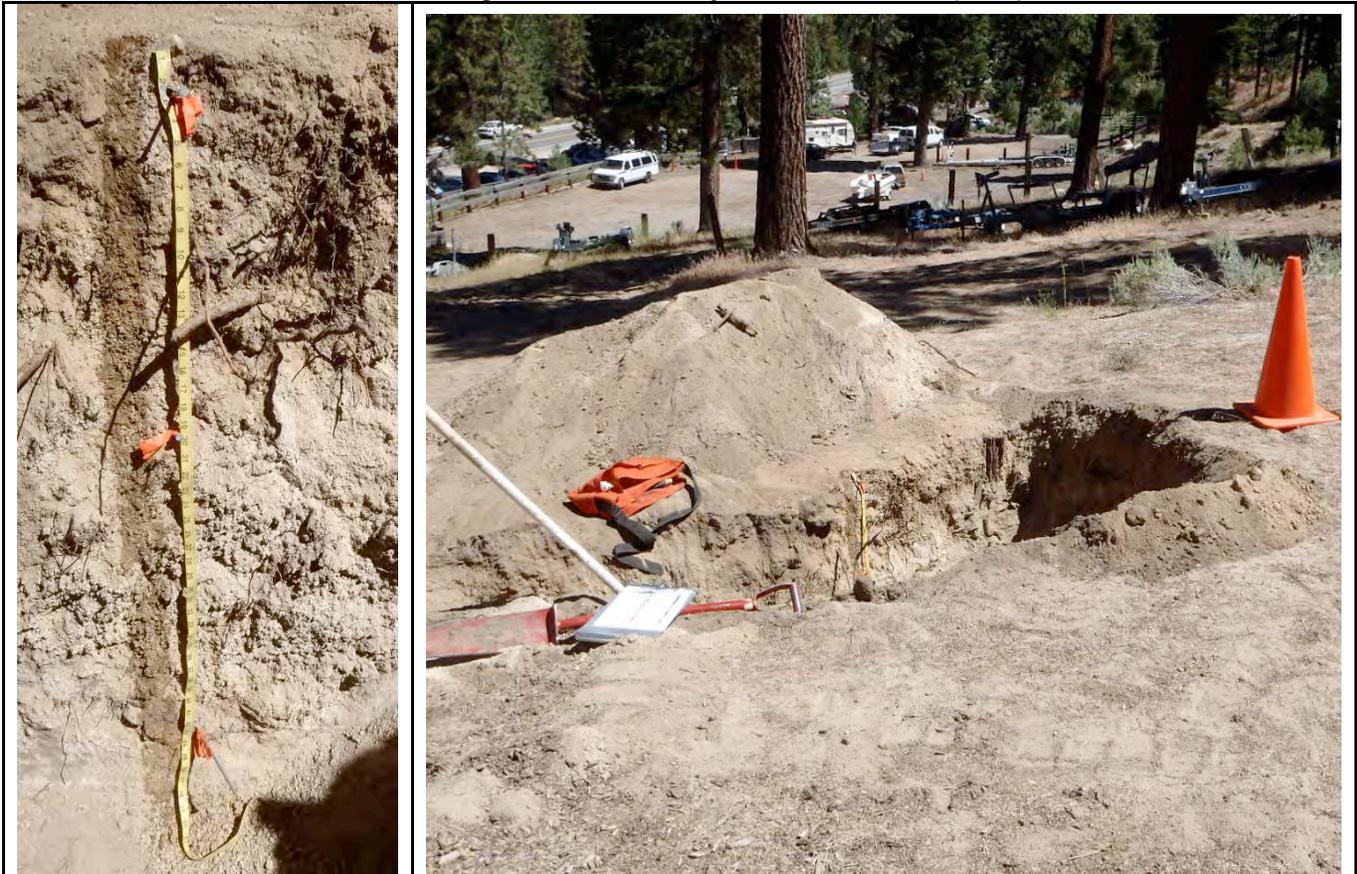
Photo 9 – View of soil profile. Test pit depth 48+ inches. Weathered bedrock occurs below 43-inch depth.

Photo 10 – View to north toward Test Pit 5, located on 17% slope, in east-center part of study area. Slope dips (falls) to north.

Layer	Depth (In.)	Color (moist)	Soil Properties / Features
A	0 to 2.5	Very dark grayish brown (10YR 3/2)	LOAMY COARSE SAND, weak granular structure, 5% gravel, 10% cobbles, no redox features, many fine and very fine roots, many med. interstitial pores, abrupt boundary. Brome grass coverage is 50%, Idaho fescue is 5%, while sagebrush cover is additional 10%, remainder is duff.
AB	2.5 to 19.5	Dark yellowish brown (10YR 3/ 4)	LOAMY COARSE SAND, weak granular structure, 10% gravel, 10% cobbles, no redox features, many fine and very fine roots, common medium roots, few coarse roots, many med. interstitial pores, clear boundary.
BC	19.5 to 43	Brown (10YR 4/3)	LOAMY COARSE SAND, massive structure, 10% gravel, 10% cobbles, no redox features, common fine and medium roots, common coarse and very coarse roots, many med. interstitial pores, abrupt boundary.
C	43 to 48	Brown (10YR 4/3)	LOAMY COARSE SAND (Grus), massive structure, 20% gravel, no redox features, few fine and coarse roots, common, med. interstitial pores. Pea-sized fragments mostly break down to loamy coarse sand when wetted – soil fines within matrix.

Soil is significantly different than mapped soils (Cagwin-Rock outcrop complex, 15-30% slopes-CaE and Inville stony coarse sandy loam, 2 to 9% slopes—IsC). See report discussion. Soil is similar, but less developed than Cassenai series (2006 NRCS soil survey, 15 to 30% slopes); however, this is an unnamed soil (XXX) in the 1974 SCS soil survey. For moderate hazard lands, slopes 16 to 30% qualify as Class 4 (20% allowable coverage).

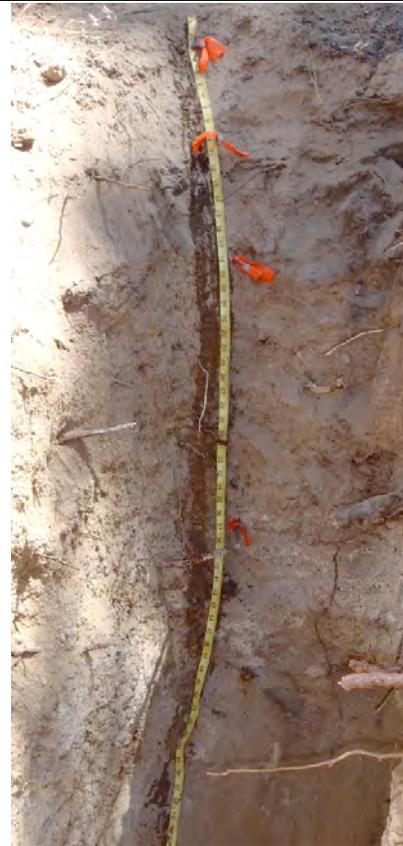
Photo 11 – View of soil profile. Test pit depth 47+ inches. Weathered bedrock occurs below 47-inch depth.

Layer	Depth (In.)	Color (moist)	Soil Properties / Features
A1	0 to 2.5	Very dark grayish brown (10YR 3/2)	LOAMY COARSE SAND, weak granular structure, 5% gravel, 10% cobbles, no redox features, many fine and very fine roots, many med. interstitial pores, abrupt boundary. Bromegrass coverage is 60%, Idaho fescue is 2%, while sagebrush cover is additional 2%, remainder is duff.
A2	2.5 to 10	Very dark grayish brown (10YR 3/2)	LOAMY COARSE SAND, weak granular structure, 5% gravel, no redox features, many fine and very fine roots, common medium roots, many med. interstitial pores, clear boundary.
Bw	10 to 18	Dark brown (10YR 3/3)	LOAMY COARSE SAND, weak subangular blocky structure, 5% gravel, no redox features, common fine and medium roots, few coarse and very coarse roots, many med. interstitial pores, abrupt boundary.
C1	18 to 37.5	Dark brown (10YR 3/3)	LOAMY COARSE SAND, massive structure, 10% gravel, no redox features, few fine roots, common medium and coarse roots, many med. interstitial pores, abrupt boundary.

C / Cr	37.5 to 47	Olive brown (2.5Y 4/3)	LOAMY COARSE SAND, massive structure, 10% gravel, no redox features, few fine, medium and coarse roots, common, med. interstitial pores.

Soil is significantly different than mapped soils (Cagwin-Rock outcrop complex, 15-30% slopes—CaE and Inville stony coarse sandy loam, 2 to 9% slopes—IsC). See report discussion. Soil is similar, but less developed than Cassenai series (2006 NRCS soil survey, 15 to 30% slopes); however, this is an unnamed soil (XXX) in the 1974 SCS soil survey. For moderate hazard lands, slopes 16 to 30% qualify as Class 4 (20% allowable coverage).

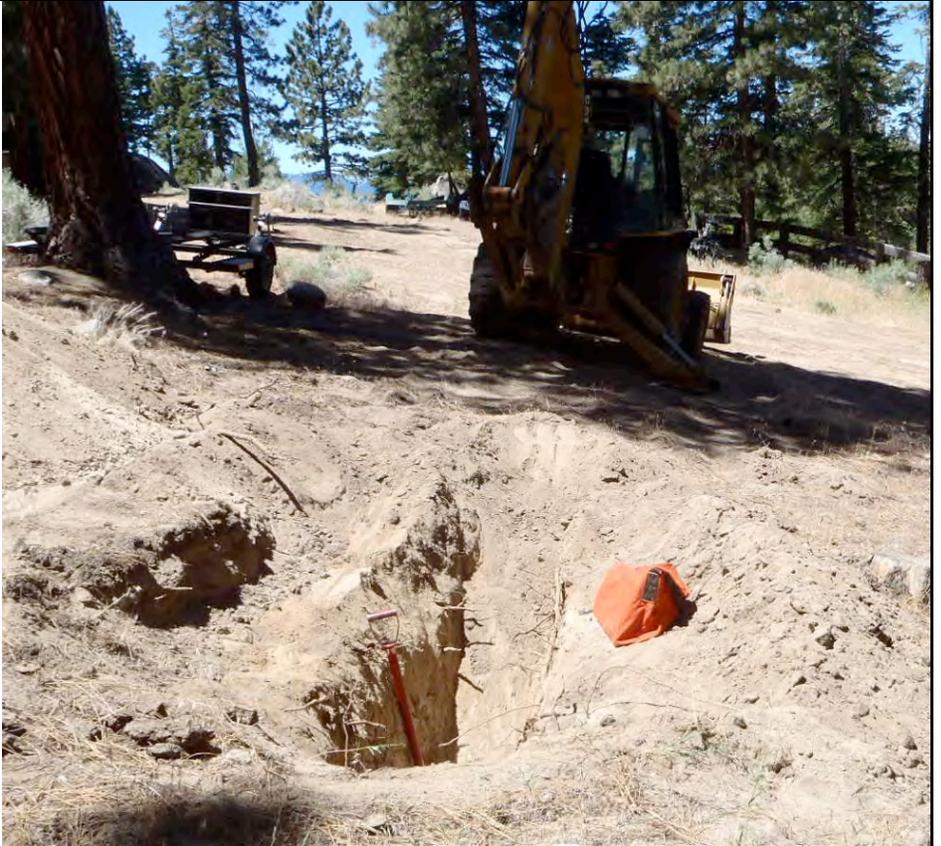
Photo 12 – View to north toward Test Pit 6, located on 19% slope, in east-center part of study area. Slope dips (falls) to north by northwest.
