MEMORANDUM

Subject: Reed Land Capability Challenge; 24 Somers Loop, Washoe County, NV;
Assessor's Parcel No: 123-033-02 and 123-033-06, TRPA File No: LCAP2016-0406

BAILEY LAND CAPABILITY CHALLENGE FINDINGS

TRPA Land Capability Challenge for
APN 123-03-02 & 123-03-06; LCAP 2016-0406
24 Somers Loop, Crystal Bay,
Washoe County, Nev.
Field Investigation: October 24 & 25, 2016
Data Analysis: November 30, 2016
Conducted By: P. Scoles

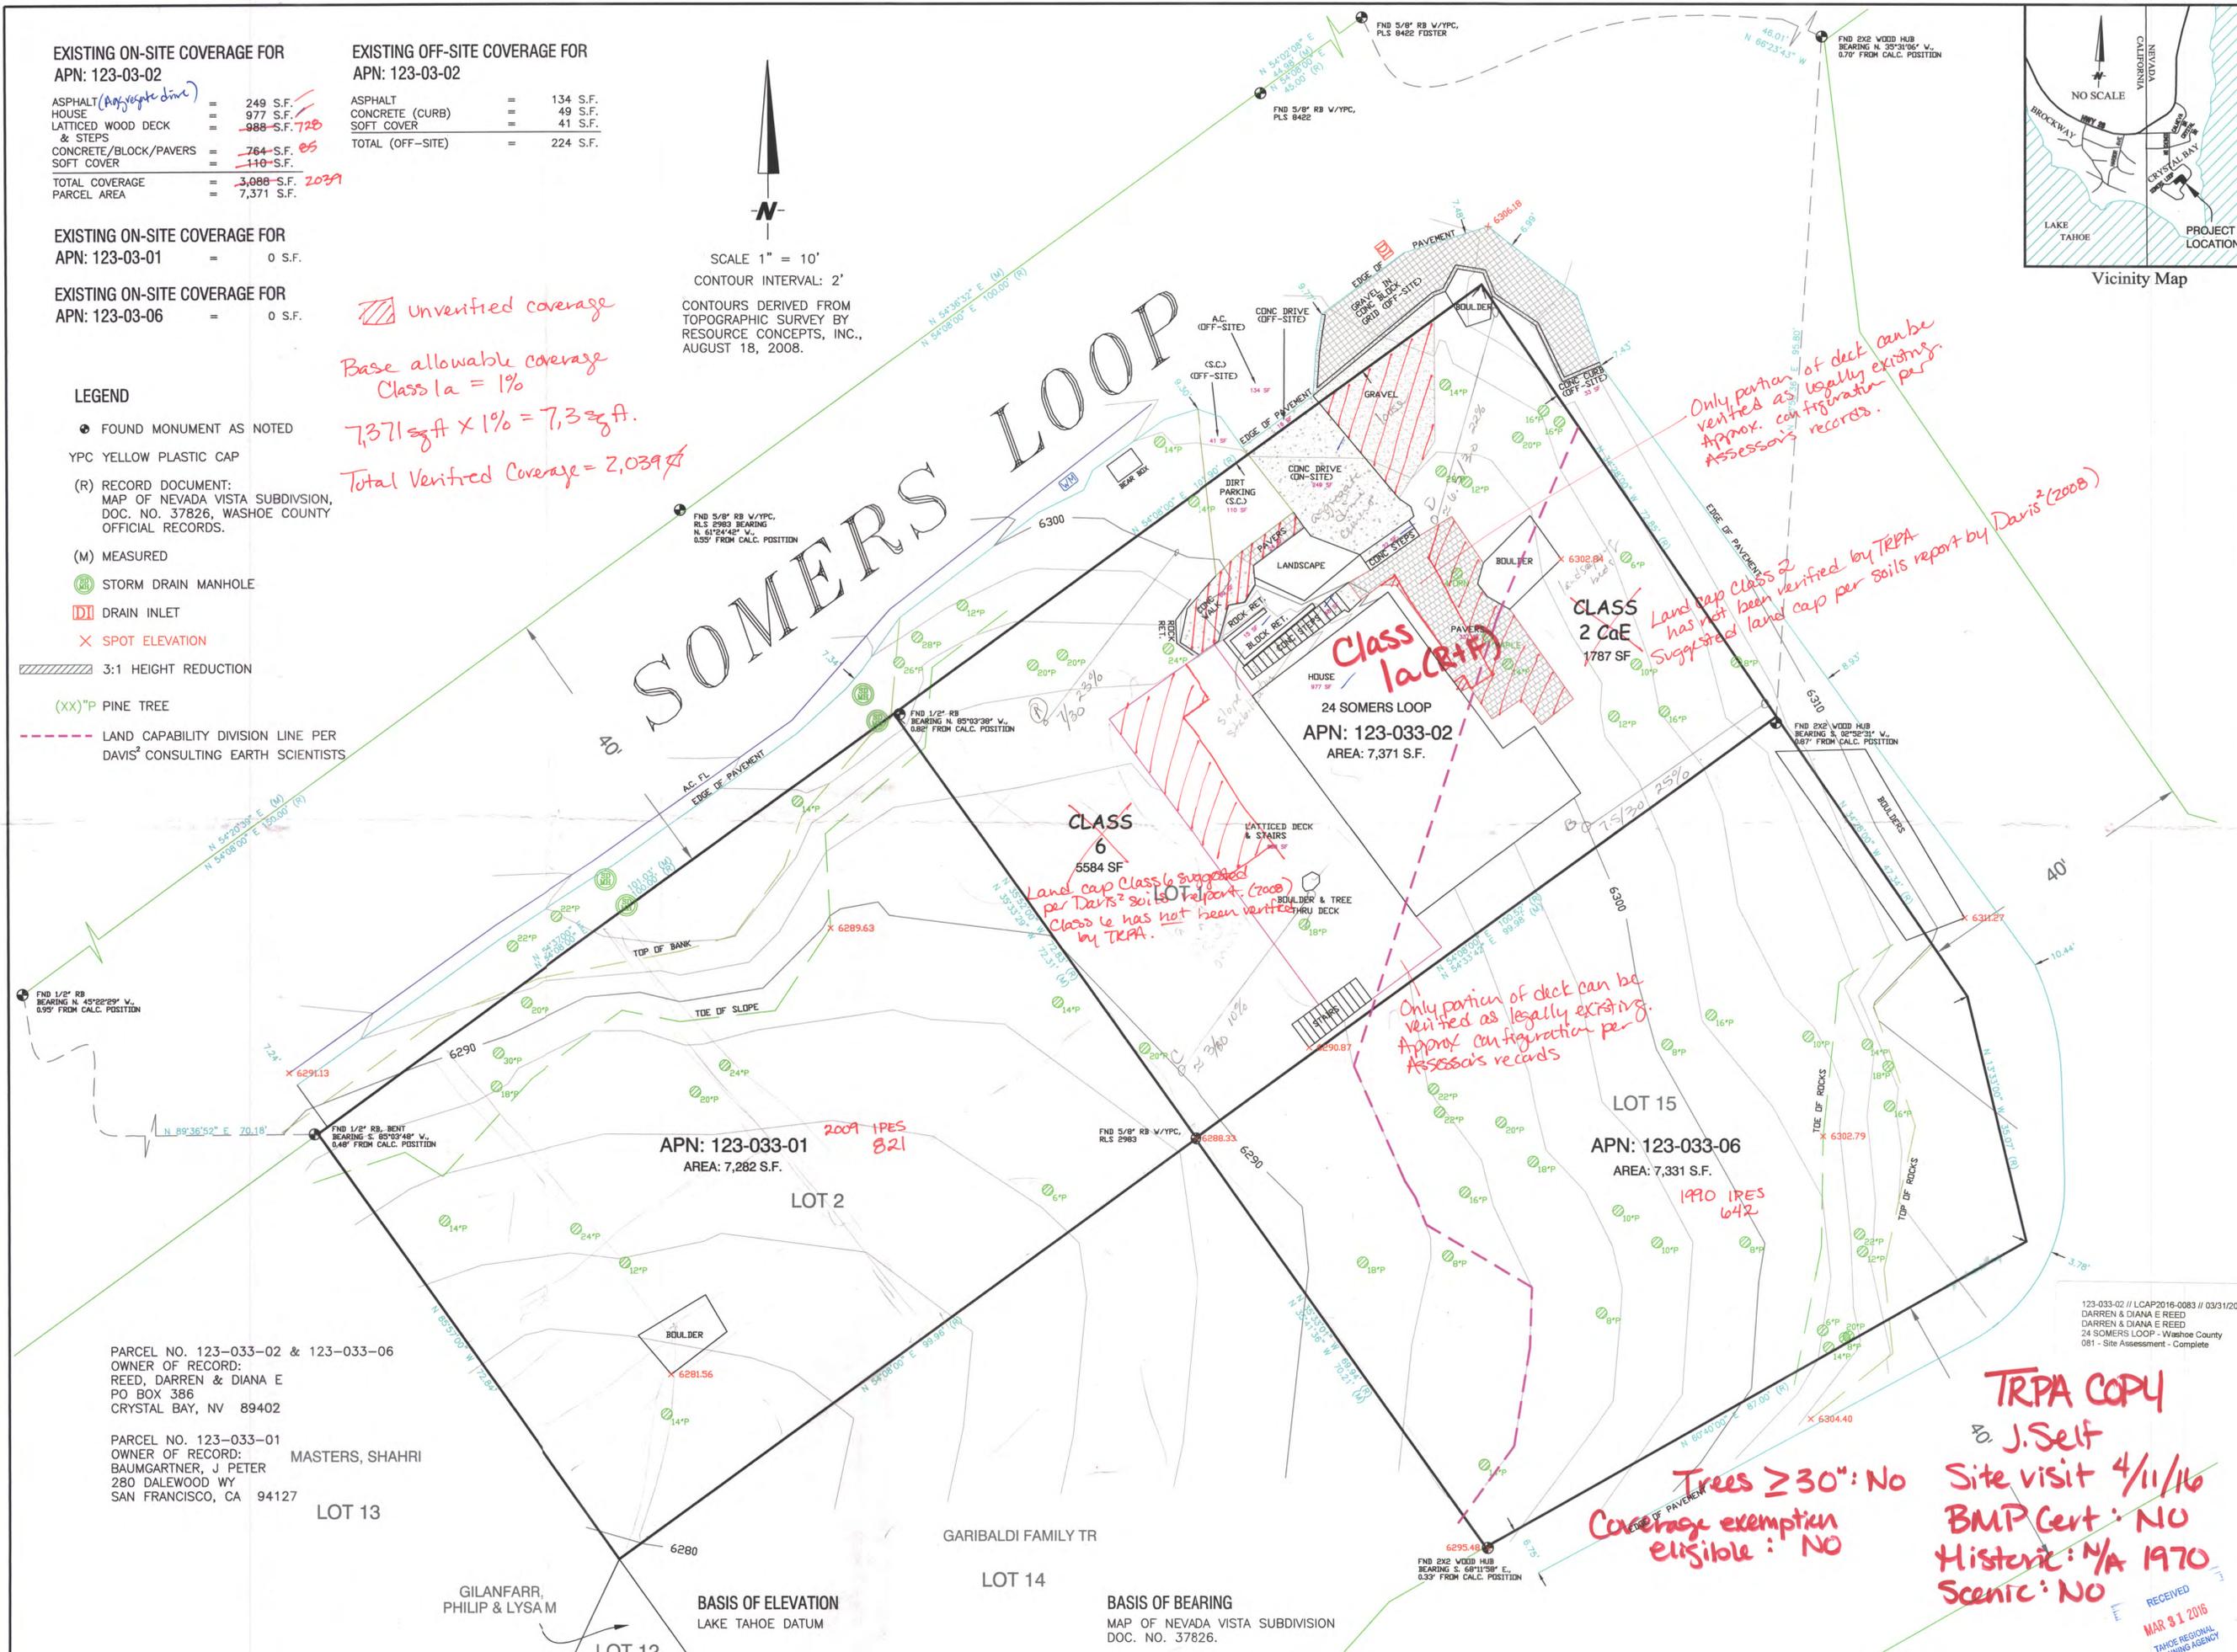
TOPOGRAPHIC AND EXISTING COVERAGE FOR
DARREN & DIANA E REED
 APN: 123-033-01, 123-033-02 & 123-033-06
 24 SOMERS LOOP
 POR. SEC. 30, T. 16 N., R. 18 E., M.D.B.M.
 WASHOE, NEVADA

SCALE 1" = 10'
 CONTOUR INTERVAL: 2'
 CONTOURS DERIVED FROM TOPOGRAPHIC SURVEY BY RESOURCE CONCEPTS, INC., AUGUST 18, 2008.

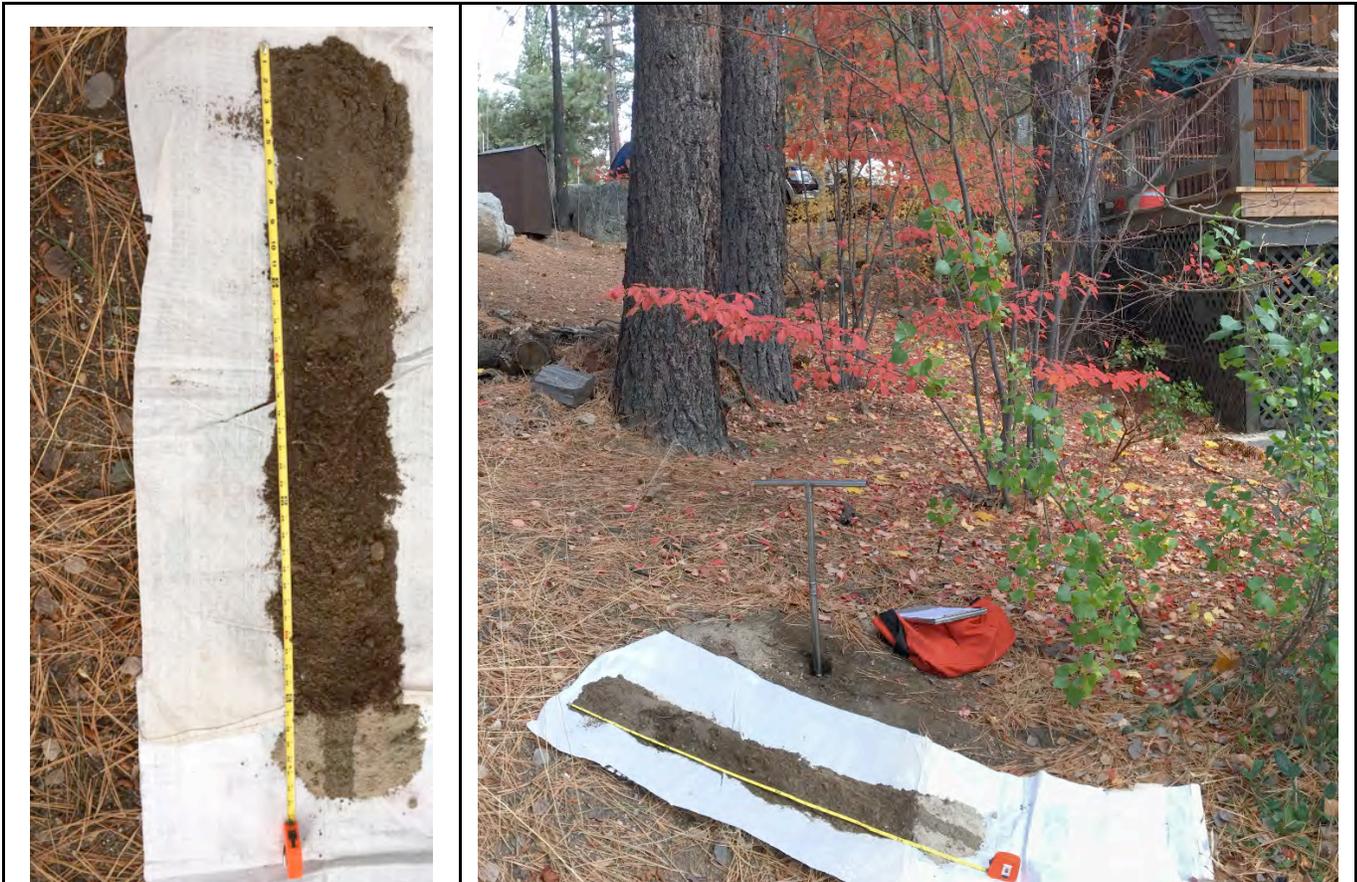
**APN 123-033-02 -- 24 Somers Loop (Darren Reed Residence),
Crystal Bay, Washoe County, Nev. – Auger Hole 1 (AH-1)**

Photo 1 – View of soil profile. Auger hole depth 43 inches.

Photo 2 – View to northeast toward AH-1, located on 12% slope (about 25 feet southeast of Somers Loop and 20 feet west of residential deck).

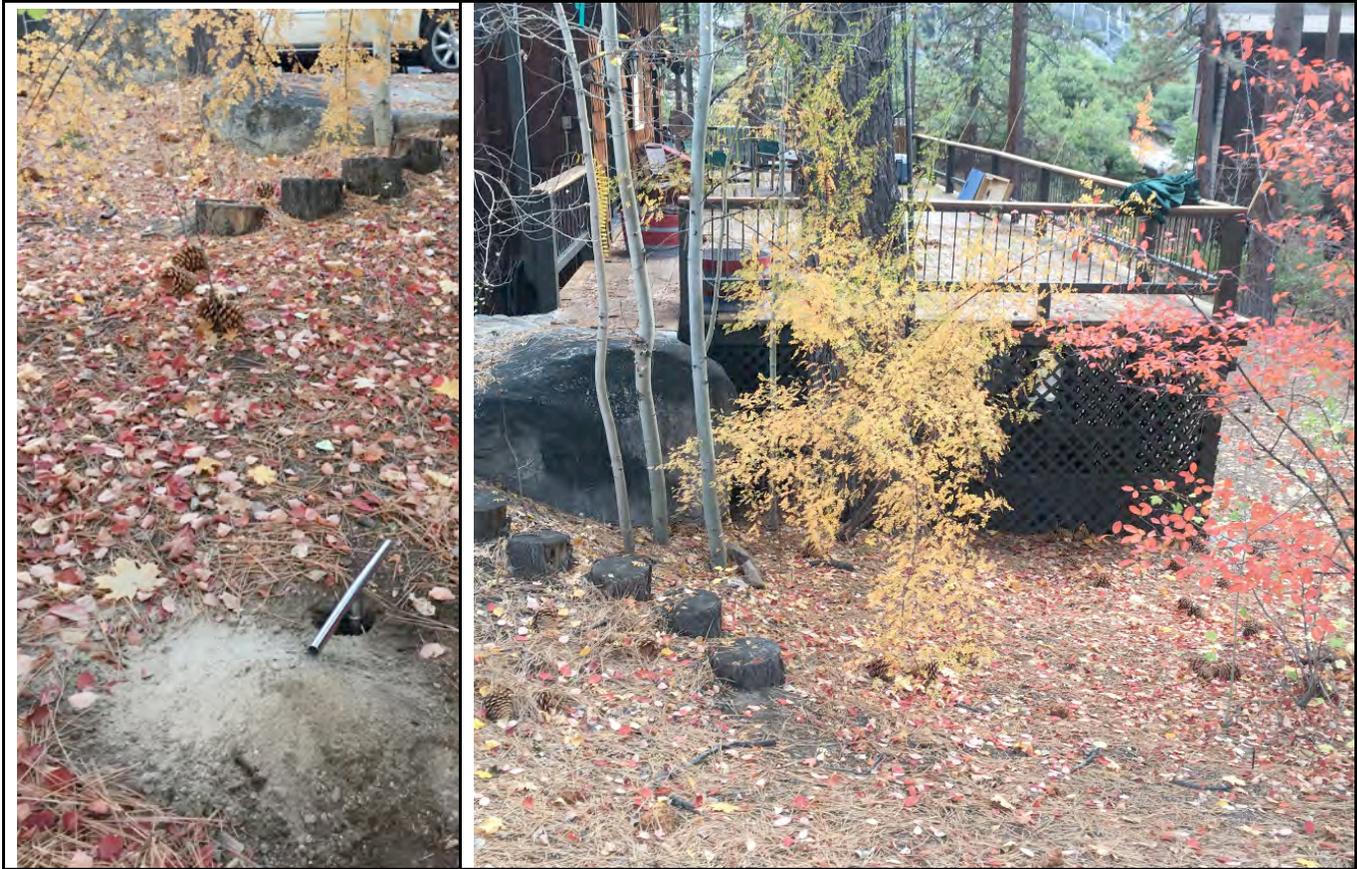
**APN 123-033-02 -- 24 Somers Loop (Darren Reed Residence),
Crystal Bay, Washoe County, Nev. – Auger Hole 2 (AH-2)**

Photo 3 – View of soil profile. Auger hole depth 56 inches.

Photo 4 – View to south toward AH-2, located on 25% slope (about 30 feet southeast of Somers Loop and 10 feet north of residential deck).

Layer	Depth (In.)	Color (moist)	Soil Properties / Features
O	0 to 1	N/A	DUFF, decomposed leaves, conifer needles, branches.
A	1 to 13	Very dark brown (10YR 2/2)	LOAMY COARSE SAND, weak granular structure, 15% gravel; no redox features, many fine roots, many fine interstitial pores, abrupt boundary.
AC	13 to 31	Very dark grayish brown (10YR 3/2)	LOAMY COARSE SAND, weak granular structure, 15% gravel; no redox features, many fine and common med. roots, many fine interstitial pores, clear boundary.
C1	31 to 39	Dark brown (10YR 3/3)	LOAMY COARSE SAND, massive structure, 15% gravel; no redox features, common fine and medium roots, few coarse roots, many fine interstitial pores, clear boundary.
C2	39 to 50	Dark grayish brown (2.5Y 4/2)	LOAMY COARSE SAND, massive structure, 25% gravel; no redox features, few fine, medium and coarse roots, many fine interstitial pores, clear boundary.
C3	50 to 56	Light brownish gray (10YR 6/2)	GRUS, massive structure, 30% gravel (pebble-size); no redox features, few fine to very fine roots, many medium interstitial pores.

Soil is significantly deeper than mapped soil (Rock outcrop-Toem complex, 30-50% slopes-RtF) – see report discussion. Soil has similar textures and depth as Cassenai series (2006 NRCS soil survey), hence it is an inclusion. Thus, it is an unnamed soil (XXX) in the 1974 SCS soil survey. For low hazard lands, slopes 16 to 30% slopes qualify as Class 4 (20% allowable coverage). Soils situated further east become shallower and qualify for Cagwin-Rock outcrop complex, 15 to 30% slopes (CaE) or Toem-Rock outcrop complex, 15 to 30+% (RtF). Both are 1% allowable coverage.

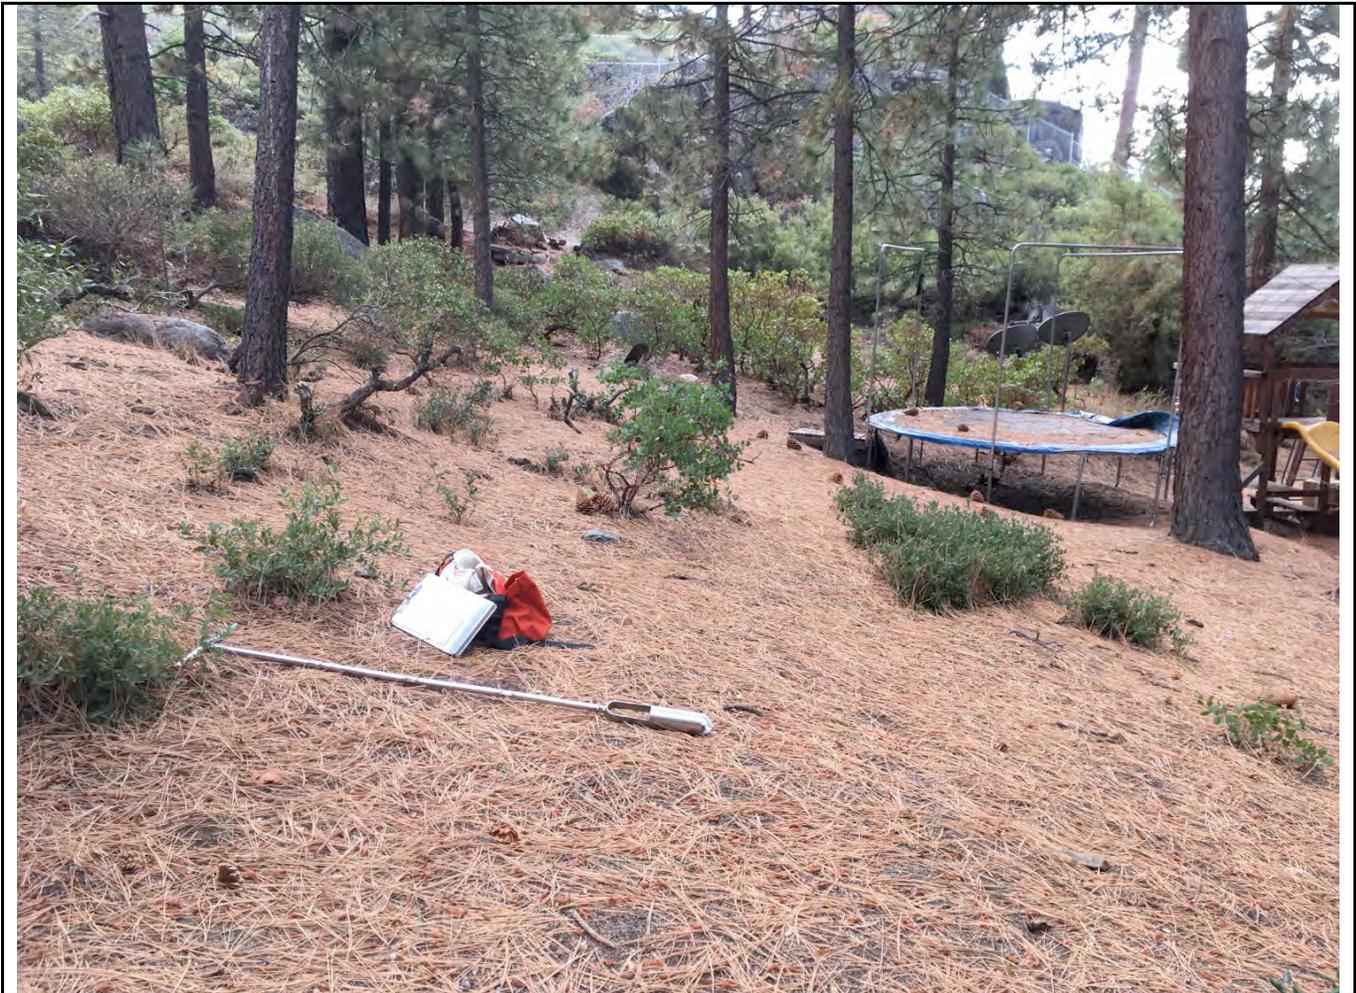
**APN 123-033-02 -- 24 Somers Loop (Darren Reed Residence),
Crystal Bay, Washoe County, Nev. – Auger Hole 3 (AH-3)**

Photo 5 – View of soil profile. Auger hole depth 13 inches.	Photo 6 – View to southeast toward AH-3, located on 22% slope (about 45 feet southwest of Somers Loop and 25 feet south of residence).
--	---

Layer	Depth (In.)	Color (moist)	Soil Properties / Features
O	0 to 1	N/A	DUFF, decomposed leaves, conifer needles, branches.
A	1 to 6	Very dark brown (10YR 2/2)	LOAMY COARSE SAND, weak granular structure, 15% gravel; no redox features, many fine roots, many fine interstitial pores, abrupt boundary.
AC	6 to 13	Dark brown (10YR 3/3)	LOAMY COARSE SAND, massive structure, 15% gravel; no redox features, many fine and common med. roots, many fine interstitial pores, clear boundary.
R	>13	N/A	ROCK REFUSAL

Soil is similar to mapped soil (Rock outcrop-Toem complex, 30-50% slopes-RtF) – see report discussion. Soil depth in the east and southeast part of study area (two lots) varies from 13 to 28 inches deep. Where these granitic soils are less than 20 inches to bedrock, they qualify as Toem soils. When they are 20 to 40 inches deep (above bedrock), they qualify as Cagwin soils. TRPA contractor Terra Science determined soil depth for applicant’s soil consultant plots 4 and 5 to have 24 to 28 inches of soil above bedrock. Both Toem and Cagwin soils are Class 2 (1% allowable coverage). Portions of this map unit have been graded for landscaping and recreation (see background in photo above).
