MEMORANDUM

Subject: Rowan Land Capability Challenge; 771 Burgundy Road, Washoe County, NV;
Assessor's Parcel No: 126-271-08; TRPA File No: LCAP2016-0392

BAILEY LAND CAPABILITY CHALLENGE FINDINGS

**Land Capability Assessment
For
Washoe Parcel APN 126-271-08**

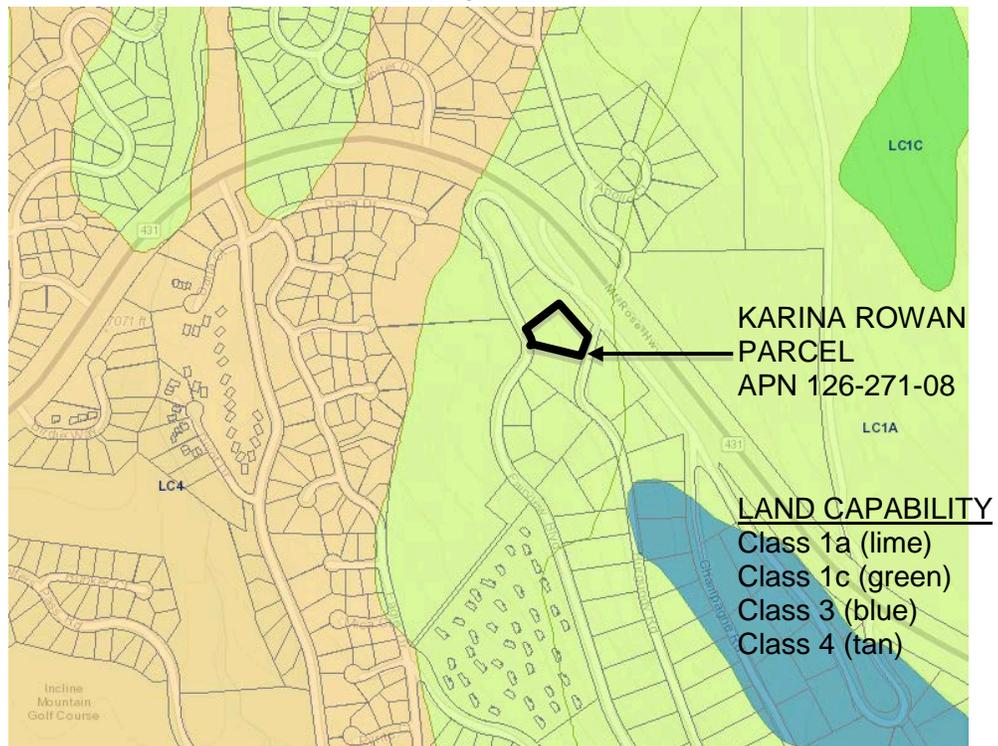
TRPA LAND CAPABILITY MAP

Background: The subject parcel is shown as Class 1a on TRPA Land Capability Overlay Maps (aka Bailey Land Capability maps). The Soil Conservation Service Soil Survey of Tahoe Basin Area, California-Nevada (Rogers, 1974) places the majority of the subject parcel within Meeks very stony loamy coarse sand (MSE, 15 to 30% slopes) soil type. The Meeks soil type is deep, well drained and very rocky soil derived from mostly granitic parent material. The soil texture is typically loamy coarse sand. The vicinity of this parcel has a geomorphic mapping of D-2 for Streamcut volcanic flow lands – Headlands lands (moderate hazard lands).

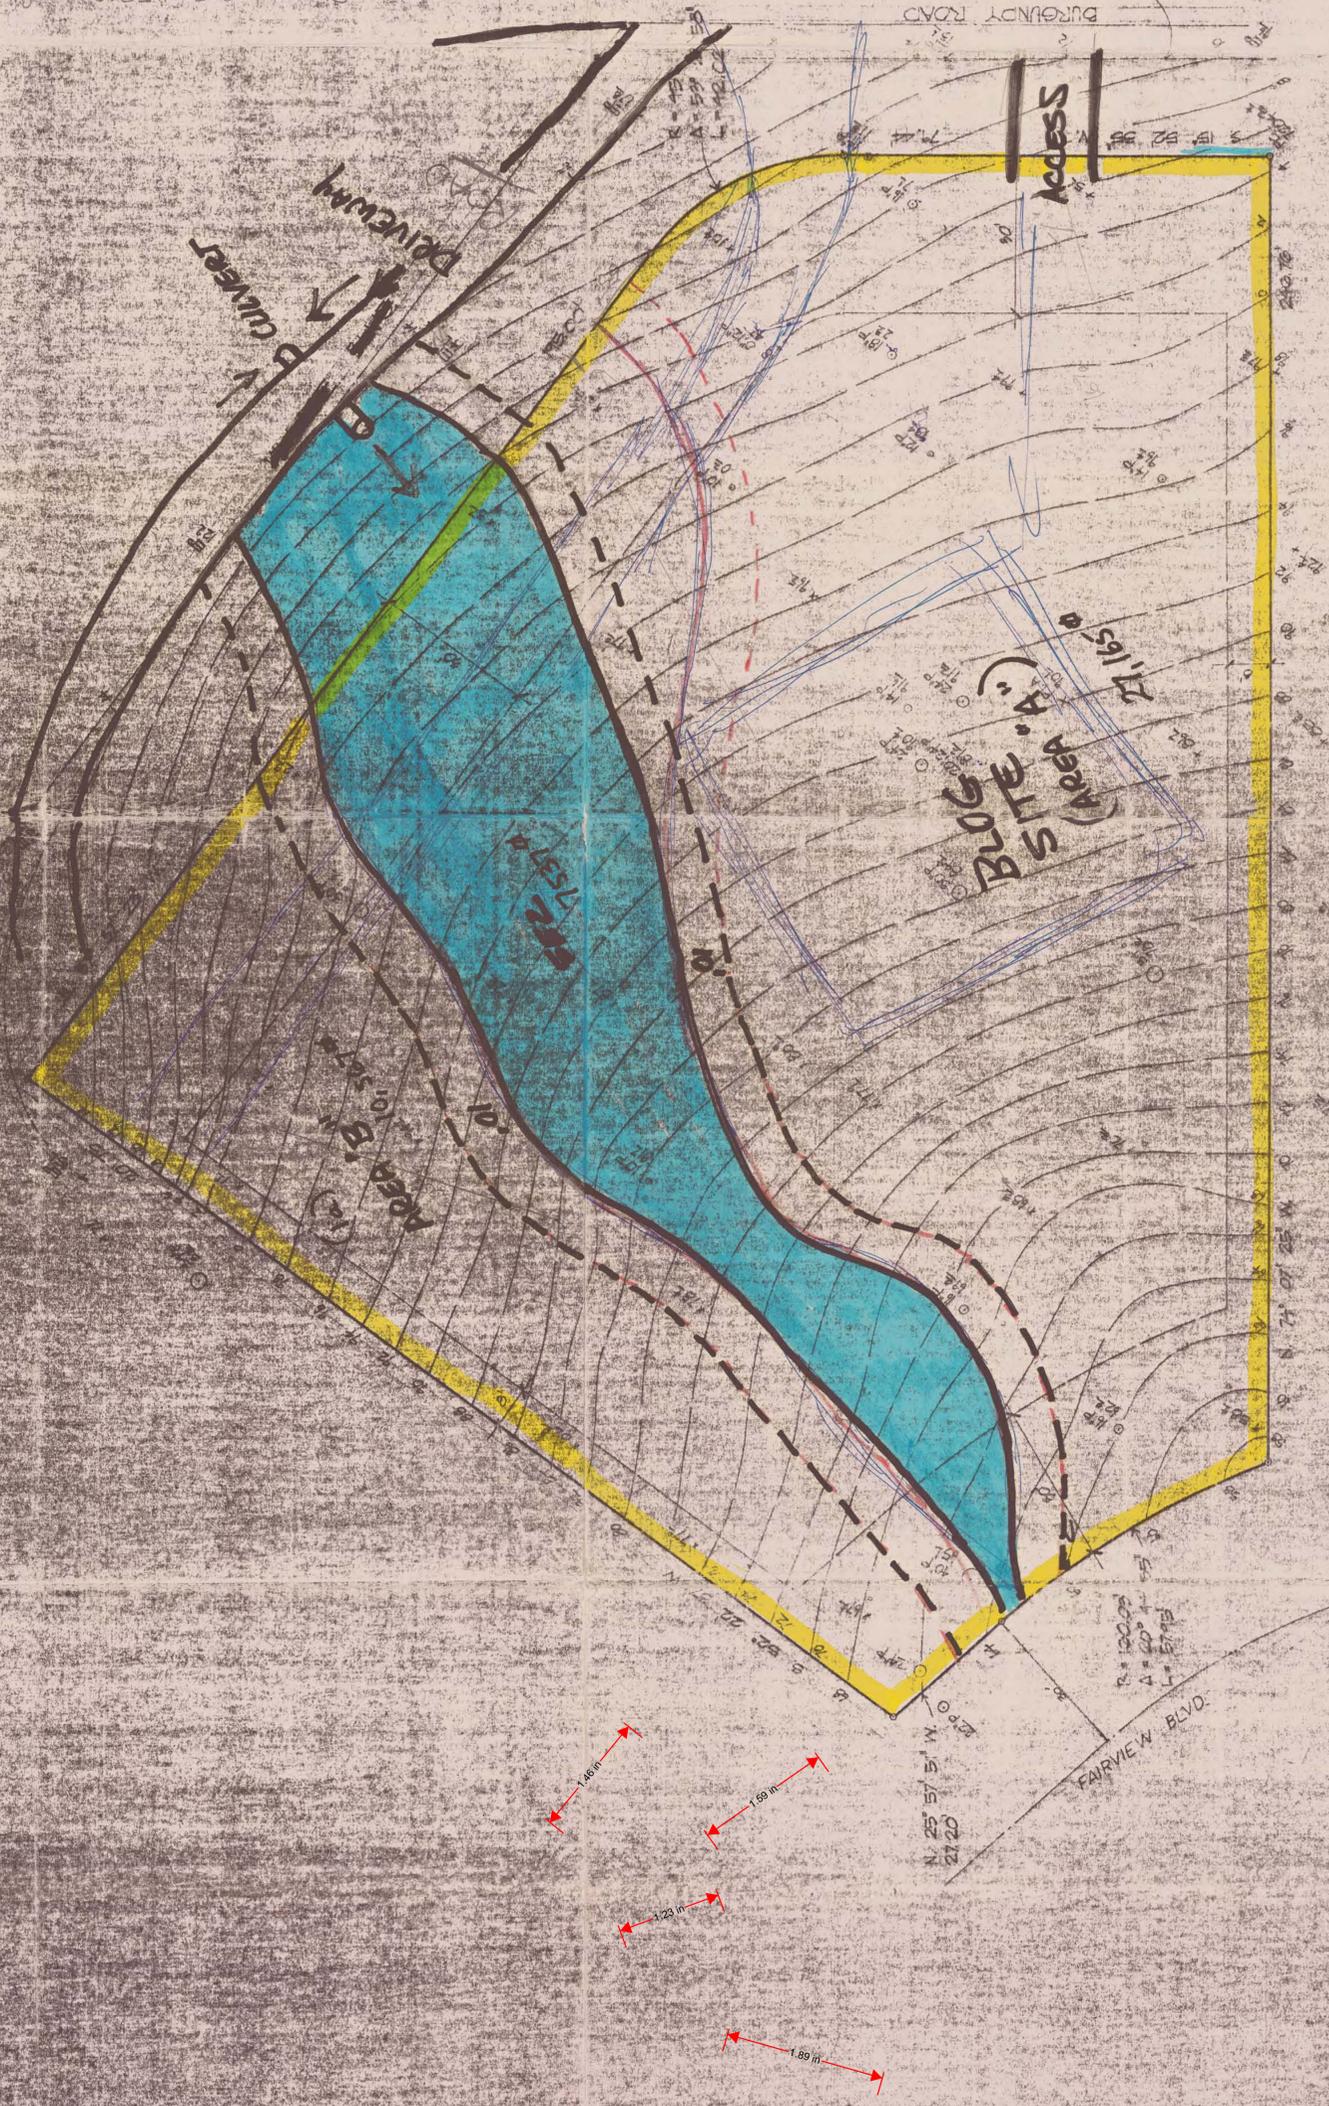
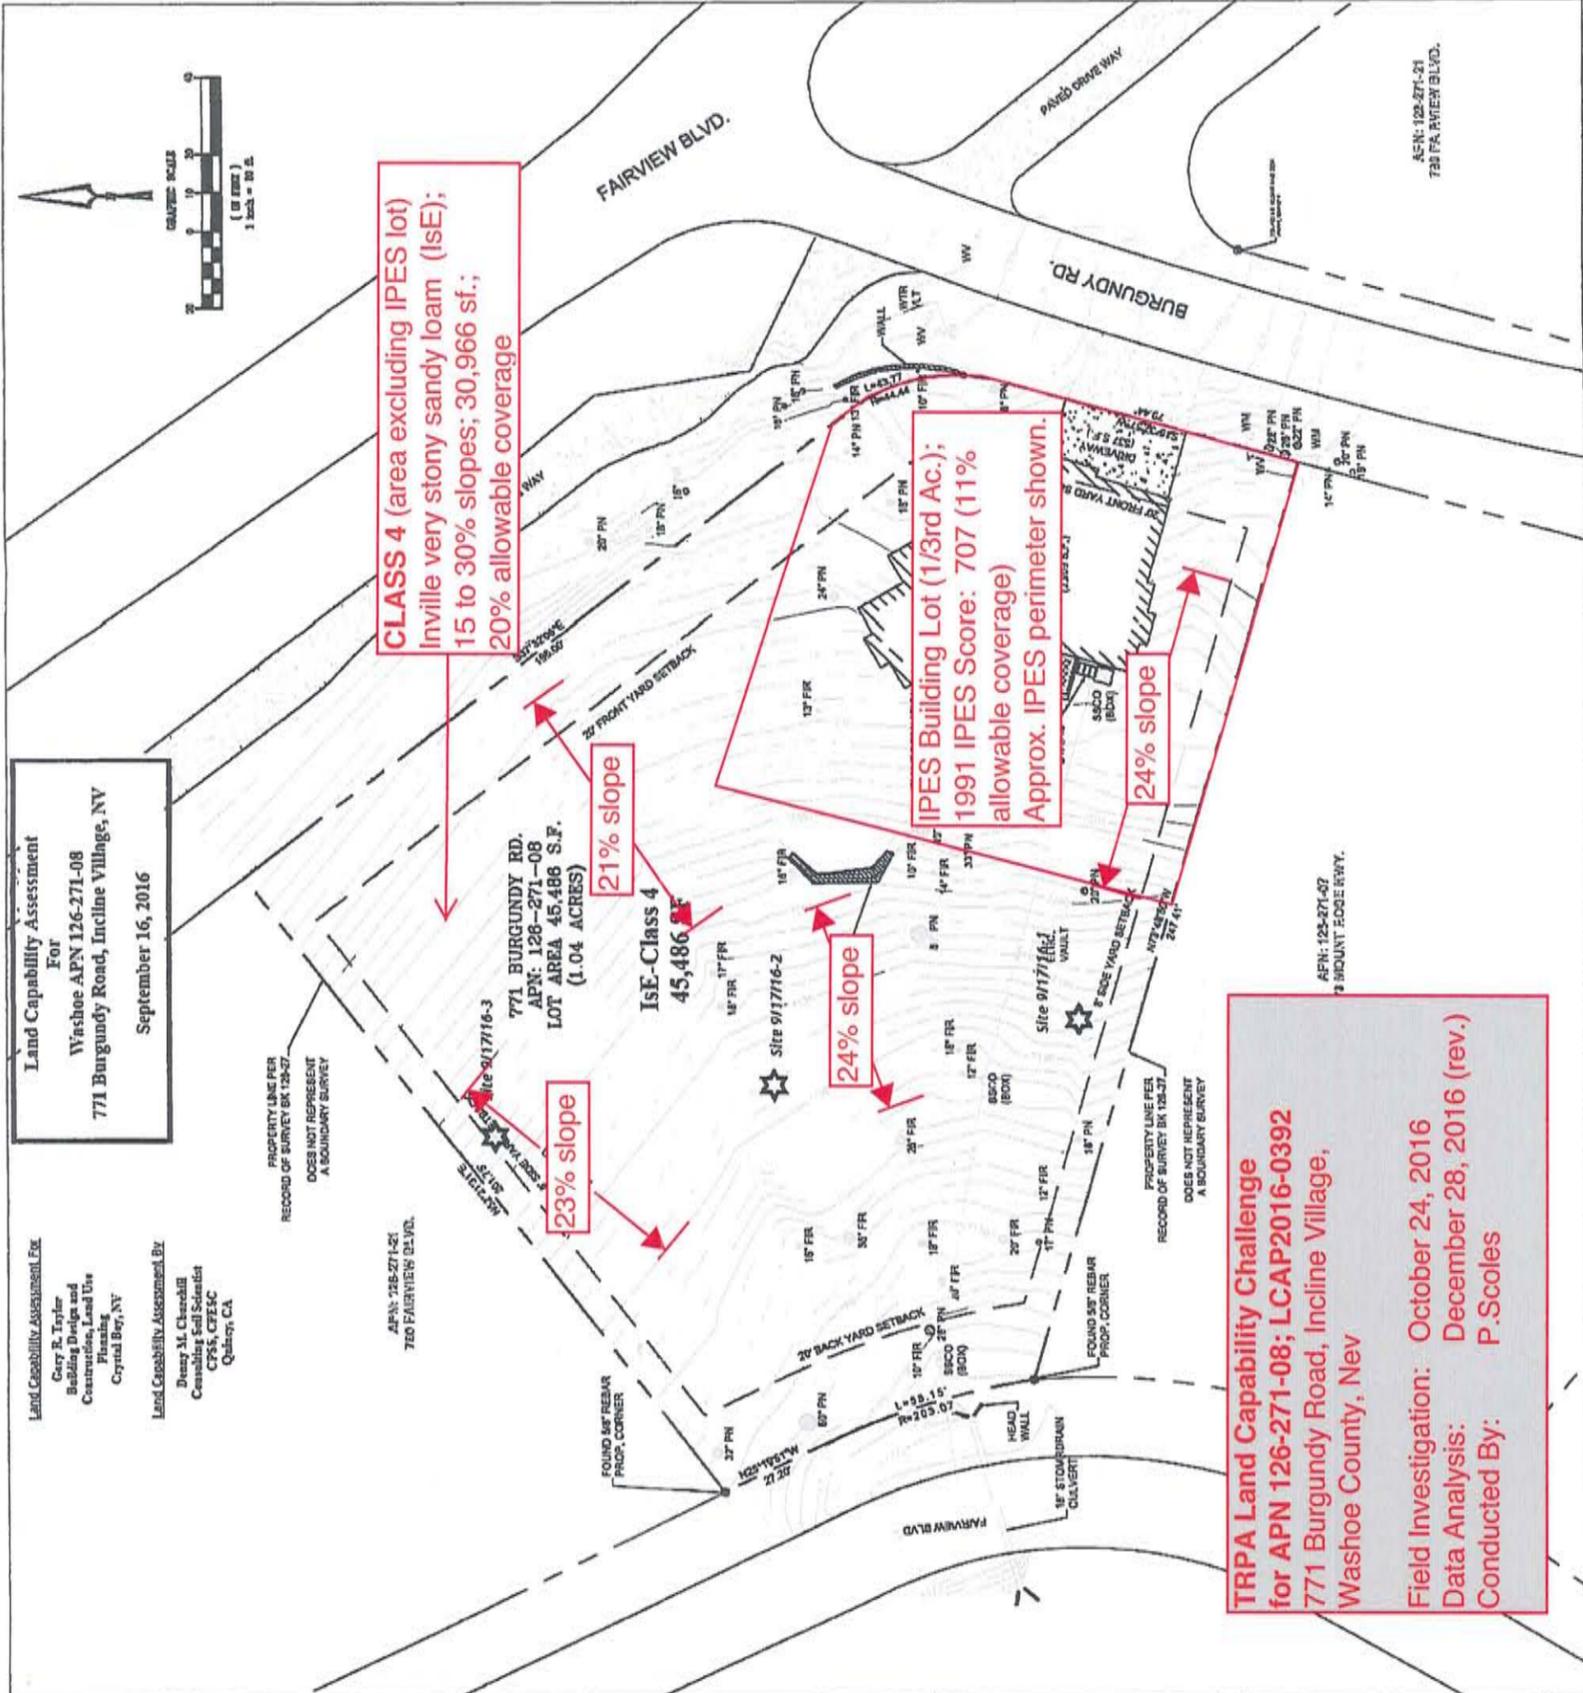
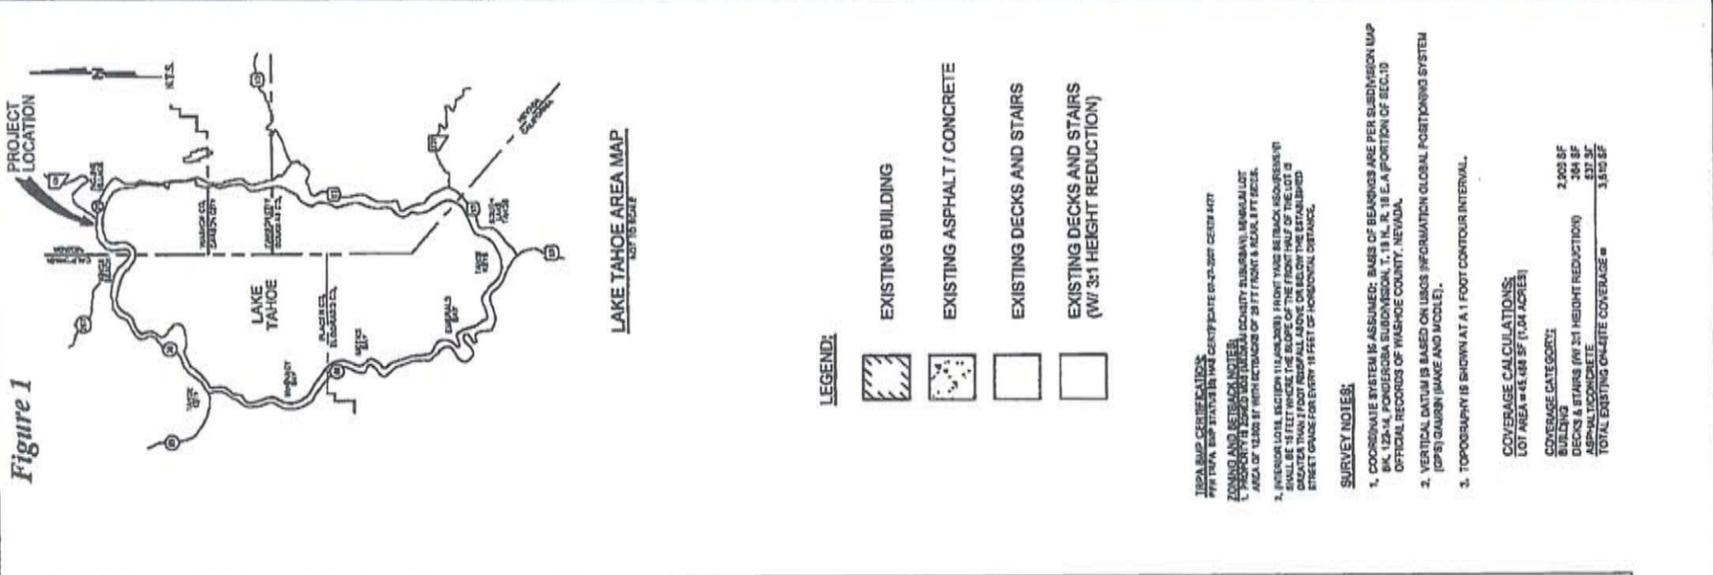
TOPOGRAPHIC SURVEY

Existing Conditions Map and Recommended Land
Capability Challenge for LCAP2016-0392

In accordance with the TRPA Land Capability Classification system, Inville soils having 15 to 30 percent slopes qualify as Class 4 (20% land coverage). The revised mapping concluded by this field investigation is consistent with the 2006 soil survey that identified the parcel as Class 4 (Meeks series which is similar to Inville series). The table below summarizes the changes in land capability and allowable land coverage as concluded by this land capability challenge.

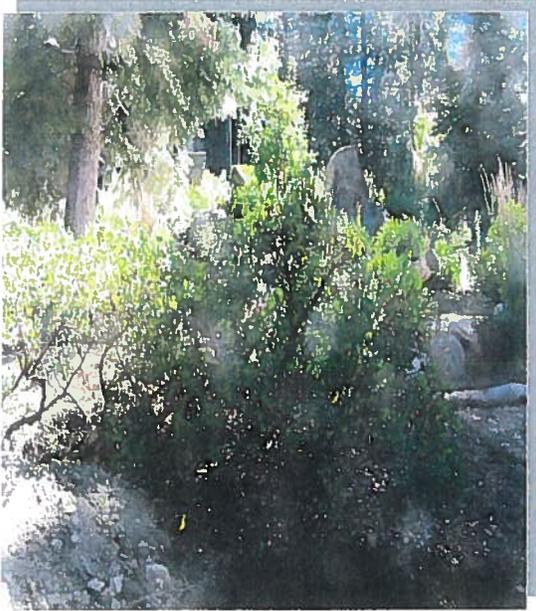
Site 9/7/16-1

Up Slope Towards The House

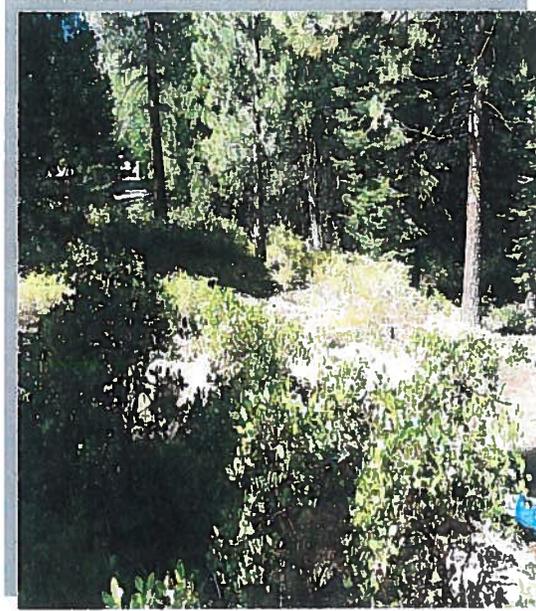
Down Slope Towards Lower Fairview

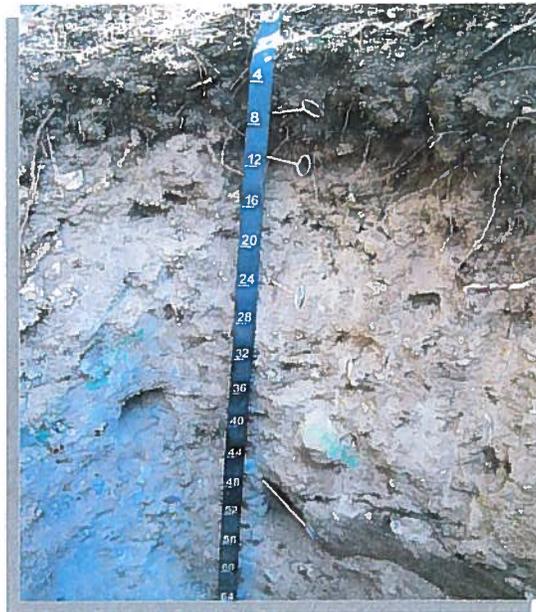
Referring to Figure 1, soils at site 9/7/16-1 are found to be deep, well drained, and members of Soil Hydrologic Group B. They can be characterized as having brown or dark yellowish brown very gravelly coarse sandy loam top soil approximately 12 inches thick, over a dark yellowish brown or brown subsoil to a depth of 65 inches. These soils are dissimilar to the Meeks very stony loamy coarse sand because they are finer textured, have the presence of illuviated clays, and lack a silica cemented pan at depth. Soils at this site fall within the range of characteristics of Inville stony coarse sandy loam.

Representative Soil Profile

Soils found at site 9/7/16-1 fall within the range of characteristics of the Inville series, place in map unit IsE-Inville stony coarse sandy loam, 15 to 30 percent slopes, and land capability district 4.

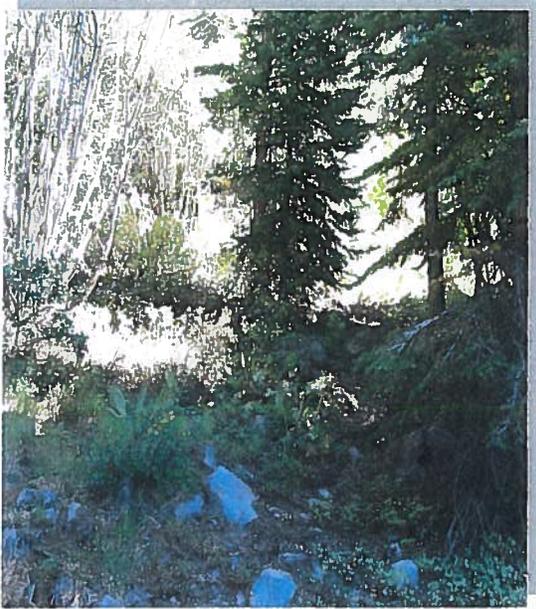
Site 9/7/16-2

Up Slope Towards Burgundy

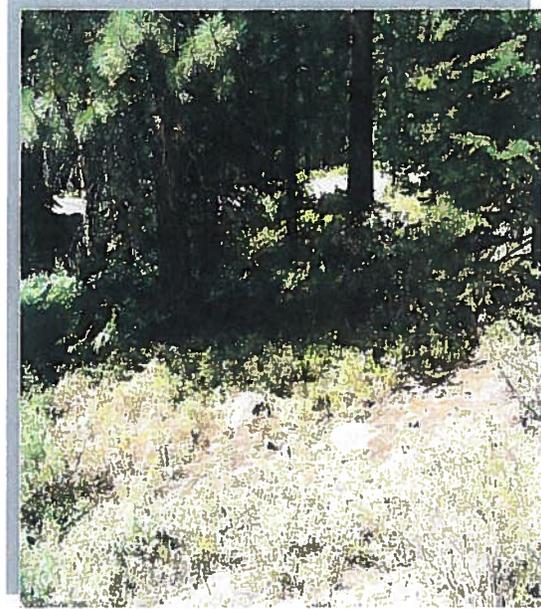
Down Slope Towards Lower Fairview

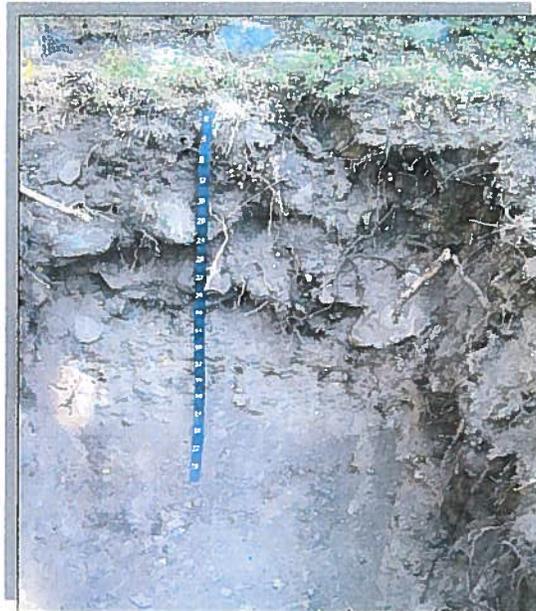
Soils at site 9/7/16-2 are found to be deep, well drained, and members of Soil Hydrologic Group B. They can be characterized as having brown or dark yellowish brown very gravelly or stony sandy loam top soil approximately 16 inches thick, over a dark yellowish brown or brown subsoil to a depth of 70 inches. These soils are dissimilar to the Meeks very stony loamy coarse sand because they are finer textured, have the presence of illuviated clays, and lack a silica cemented pan at depth. Soils at this site fall within the range of characteristics of Inville stony coarse sandy loam.

Representative Soil Profile

Soils found at site 9/7/16-2 fall within the range of characteristics of the Inville series, place in map unit IsE-Inville stony coarse sandy loam, 15 to 30 percent slopes, and land capability district 4.

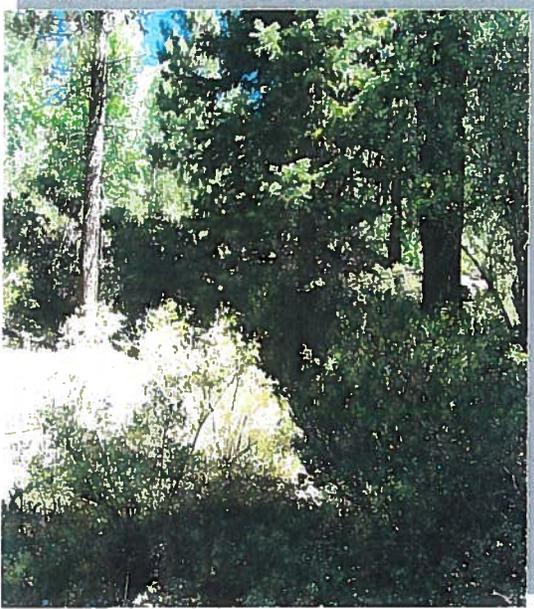
Site 9/7/16-3

Up Slope Towards Burgundy

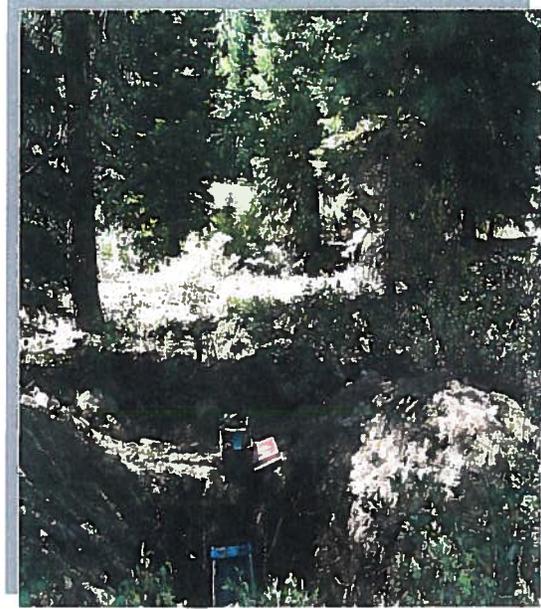
Down Slope Towards Lower Fairview

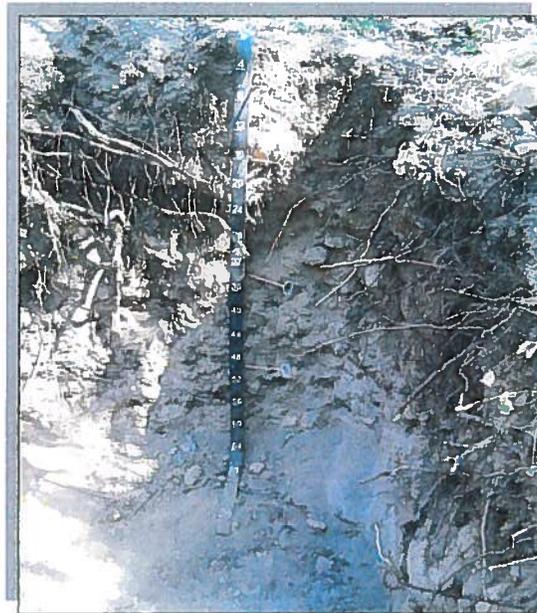
Soils at site 9/7/16-3 are found to be deep, well drained, and members of Soil Hydrologic Group B. They can be characterized as having brown or dark yellowish brown very gravelly or very stony coarse sandy loam top soil approximately 16 inches thick, over a dark yellowish brown or brown subsoil to a depth of 70 inches. These soils are dissimilar to the Meeks very stony loamy coarse sand because they are finer textured, have the presence of illuviated clays, and lack a silica cemented pan at depth. Soils at this site fall within the range of characteristics of Inville stony coarse sandy loam.

Representative Soil Profile

Soils found at site 9/7/16-3 fall within the range of characteristics of the Inville series, place in map unit IsE-Inville stony coarse sandy loam, 15 to 30 percent slopes, and land capability district 4.

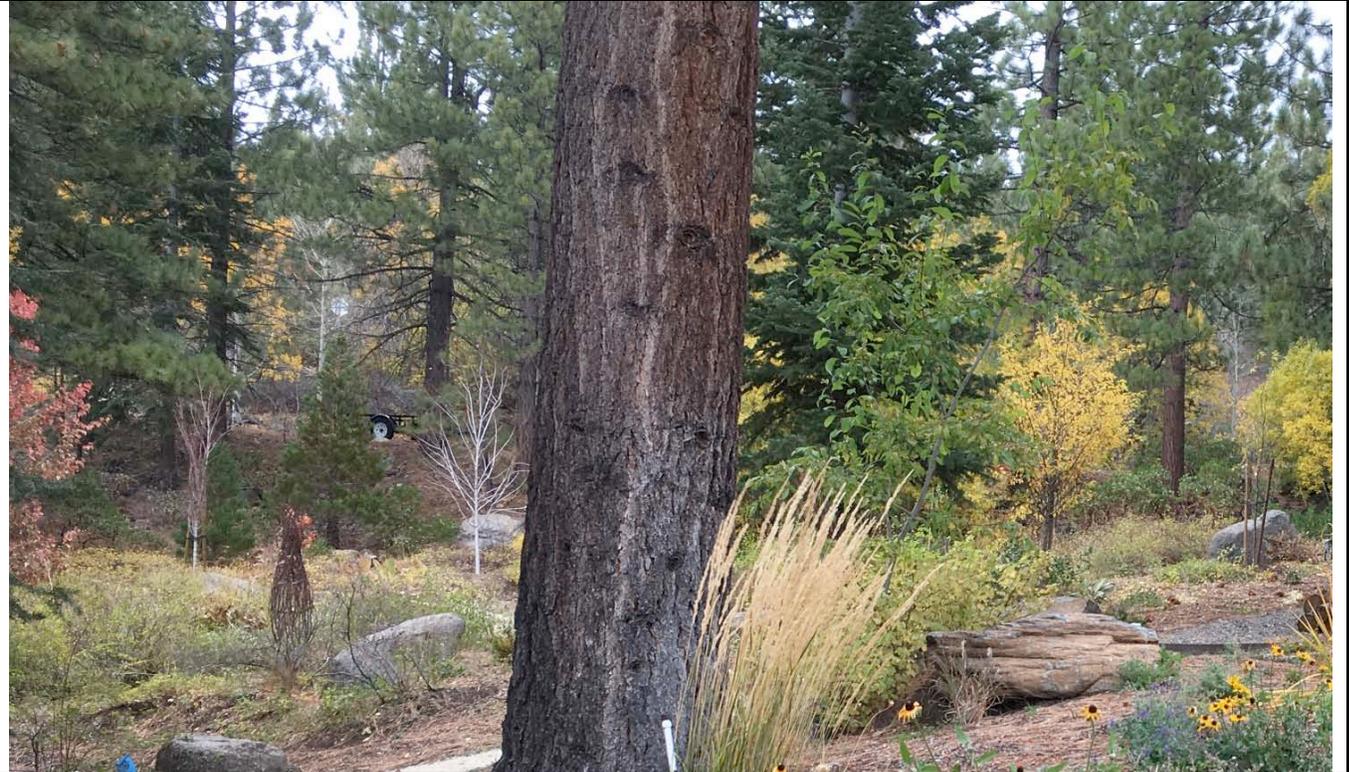
Photo 1 – View to north toward broad swale situated north by northwest of existing residence. While swale includes some ornamental trees, shrubs and herbaceous plants, the upper reach contains white fir, scouler’s willow, incense cedar, snowberry, whitethorn, and bitterbrush.

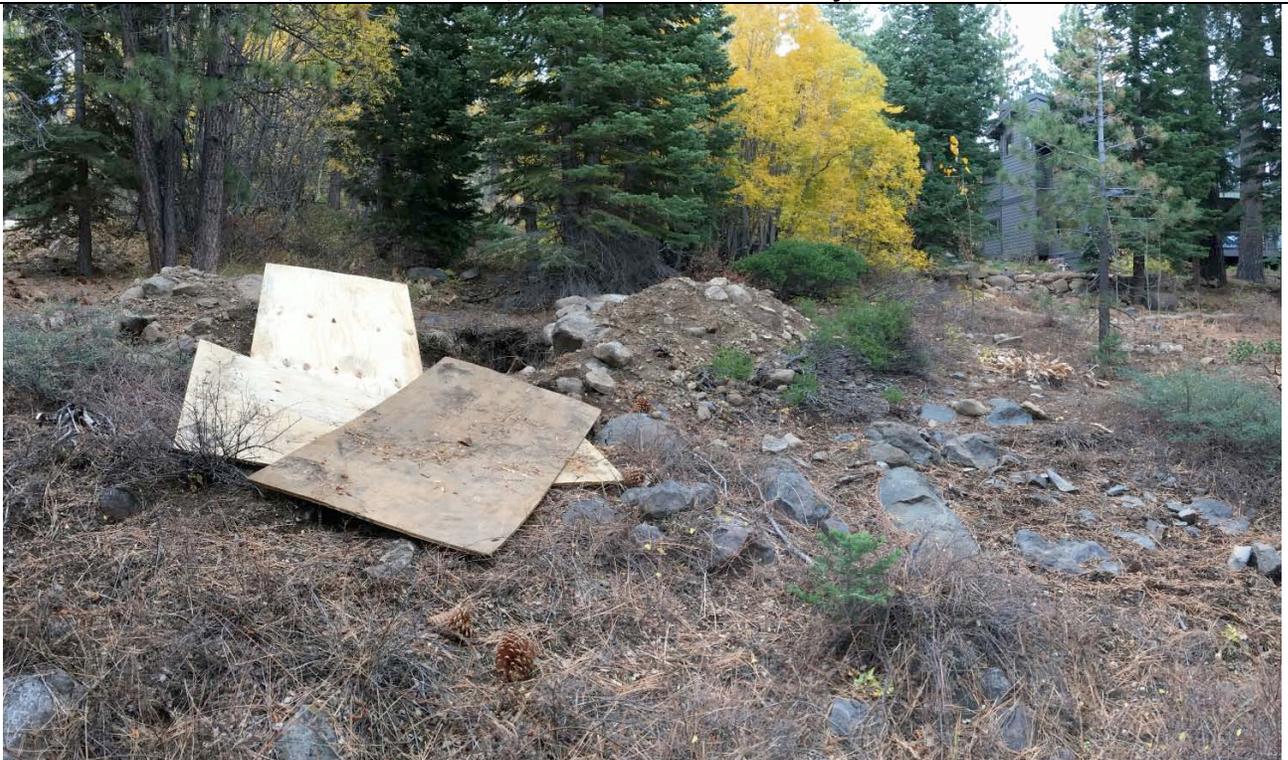
Photo 2 – View to northeast upward at broad swale situated north by northwest of existing residence. Vegetation with close proximity of soil test pit 9/7/16-2 includes white fir, scouler’s willow, green leaf Manzanita, bitterbrush, whitethorn and prostrate ceanothus. This plant community does not qualify for primary or secondary SEZ plant community.

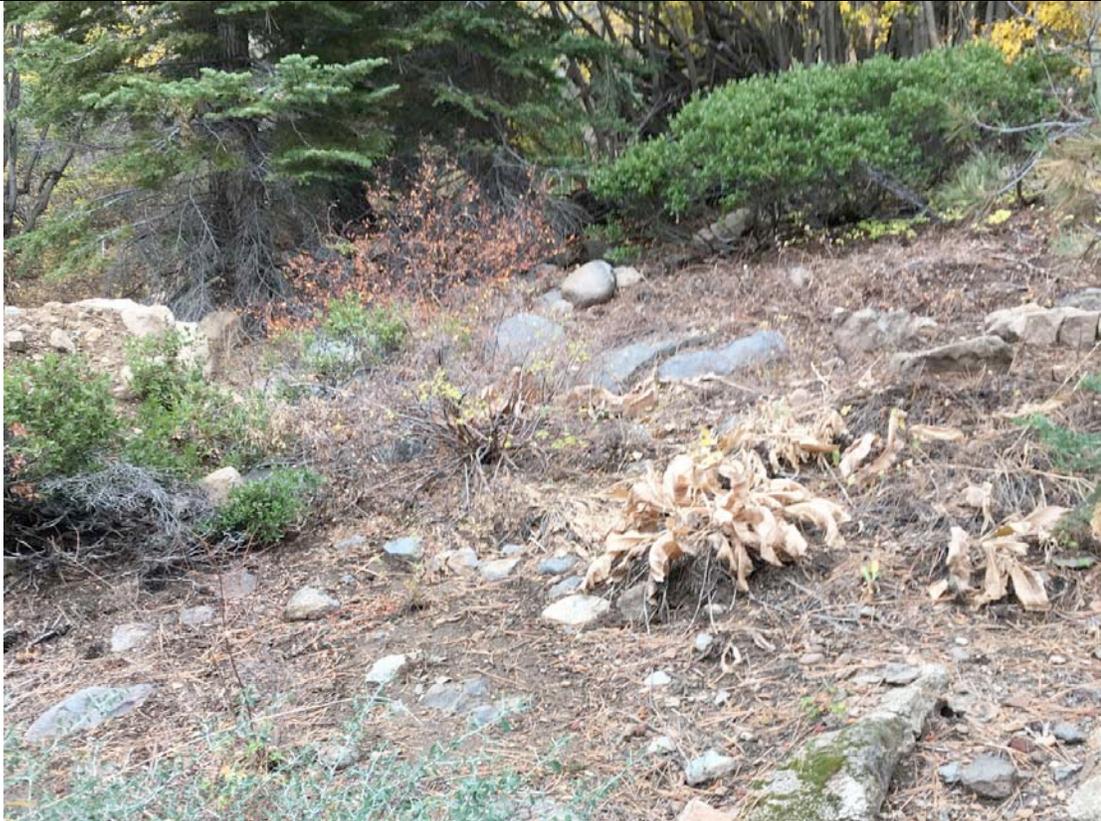
Photo 3 – View of vegetation in vicinity of soil test pit 9/7/16-2 (located in center of mapped SEZ). Ground cover plants are typically most indicative of SEZ conditions, but this location contains green leaf manzanita, currant, snowberry, mulesears, and whitethorn (foreground).

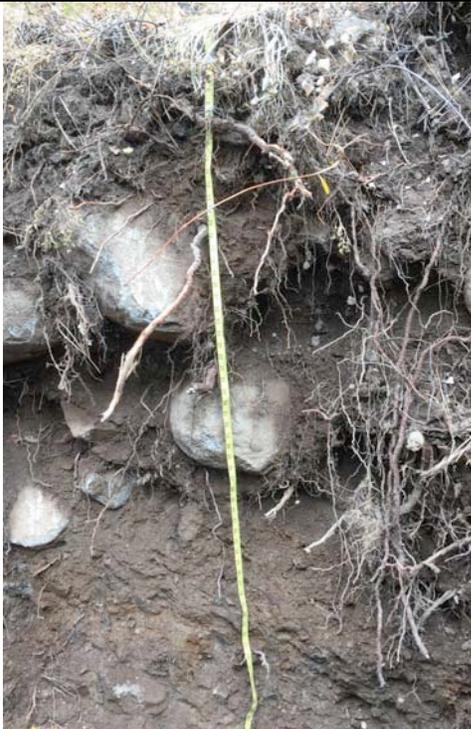
Photo 4 – View of test pit 9/7/16-2 soil with large stones and boulders. Upper 53 inches lacks evidence of water table.

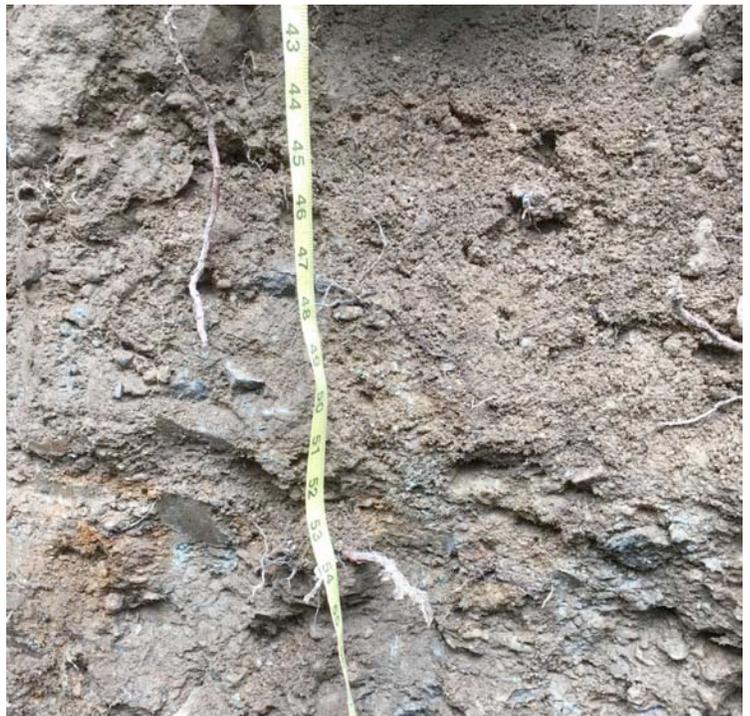
Two soil pits were found to be well drained, with no evidence of seasonal high water table in upper 65 to 70 inches (no redoximorphic features, hence HSG-B). The third pit (located in the area previously verified as SEZ) had iron staining (redoximorphic features) beginning at 53 inches. This makes the soil moderately well drained and seasonal water table not sufficiently close to the 20 to 40 inch range for a secondary SEZ indicator. The vegetation in the broad swale or hollow consists mostly of white fir, Jeffrey pine (young), Scouler’s willow, green leaf manzanita, snowbush, snowberry, currant, bitterbrush, whitethorn, prostrate ceanothus, and mules ears. See photographs in consultant’s report and from TRPA’s contractor in Attachment C. Aside from the willow, the plant community in the broad swale is not typical of an SEZ, but rather an upland.

Photo 5 – Close up view of test pit 9/7/16-2 soil profile. Iron staining on soil at 53 in. is evidence of upper limit of seasonal high water table. Soil does not qualify as secondary SEZ.
